<u>PROJECT NO.</u> S17206-1	<u>PAGE NO.</u> 1
<u>DAILY FIELD REPORT NO.</u> S17206-1	<u>DATE</u> March 24, 2017

<u>PROJECT I.D.</u> North Wandermere Estates Lane	<u>LOCATION OR ADDRESS</u> 13811 N. Wandermere Estates Lane, Spokane, WA	<u>DAY OF THE WEEK</u> Friday
<u>PREVIOUS REPORT</u>		<u>WEATHER</u> Cool, Overcast
<u>CLIENT</u> Webb Properties, Inc.		<u>PROJECT PROFESSIONAL</u> Bill Clevenger (BC)
<u>CLIENT REPRESENTATIVE</u> Eric Lundin (EL)		<u>SUPERVISOR</u> John Finnegan
<u>PERSONNEL ON SITE</u> BC, EL, Dan Berger (resident)		<u>EQUIPMENT ON SITE</u> None

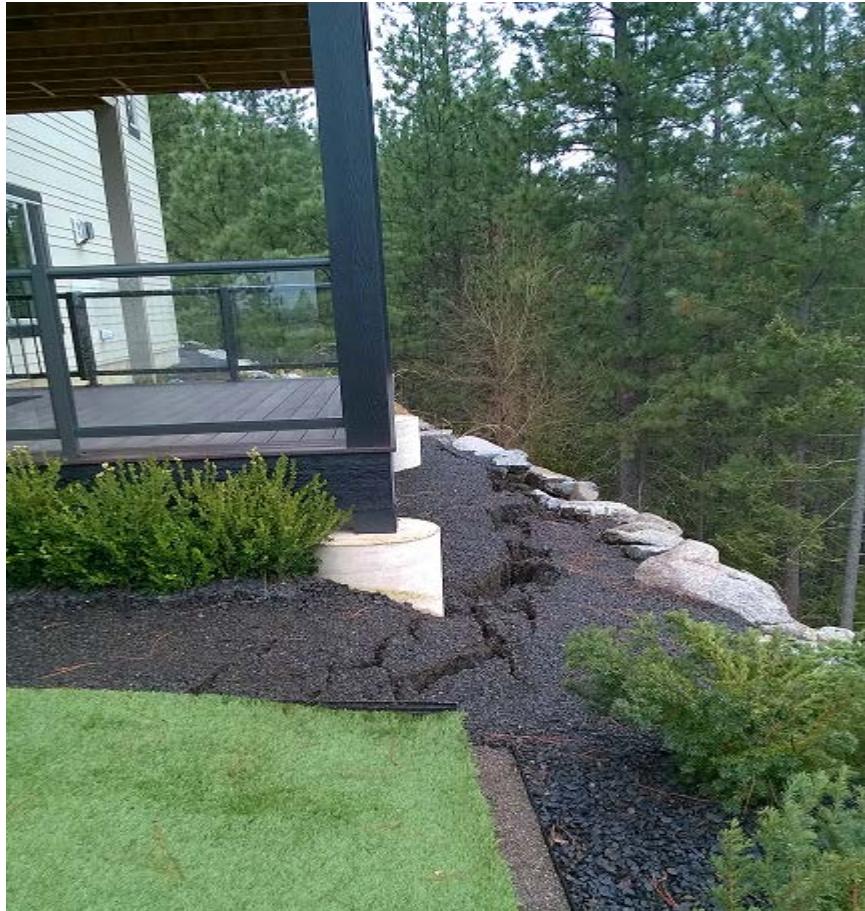
Dan Berger indicated that there has been movement of the north end of the lower retaining wall. Specifically, he stated that a portion of that wall has dropped relative to the remaining wall. He identified an apparent gap in the wall at the location where the wall appears to slant downward toward the north. On closer observation, I was unable to determine if the wall had dropped or if it had dropped recently or sometime in the past. However, the very north end (about 6 to 8 feet) appeared to have been damaged by a large fallen rock. Along the top of the wall, a few of the CMU blocks were uneven indicating some possible small displacement. John Finnegan from our office indicated that results of previous subsurface explorations may be available in the area of the site.

Significant damage to the residence at 13811 North Wandermere Estates Lane has occurred. The west side of the house has dropped down as indicated by large cracks in the foundation walls and basement floors. The floors have separated from the walls enough to see daylight between them. A large crack in the floor at the south side of the house was about two feet deep in portions. The house has been red tagged by the County as "Unsafe to Occupy."

A scarp was present extending from the basement fracture southwest across the backyard of the residence to the south. It continued just beyond the supports for that residence's back deck, terminating at the top of the rock wall west of the building. There was no apparent damage to the foundation walls of that house. However, because the scarp indications are consistent with the damage to the northerly residence, our opinion is that the house should be red tagged until it can be determined that it is safe to occupy.

It is likely that recent snow melting and rainfall have contributed to the conditions at this location. At this time, rainfall is expected over the next several days. We recommend that further geotechnical exploration and evaluation be conducted as soon as practical to identify the area of concern and determine potential solutions.
