Copper Canyon Lane Retaining Wall

April 17, 2017

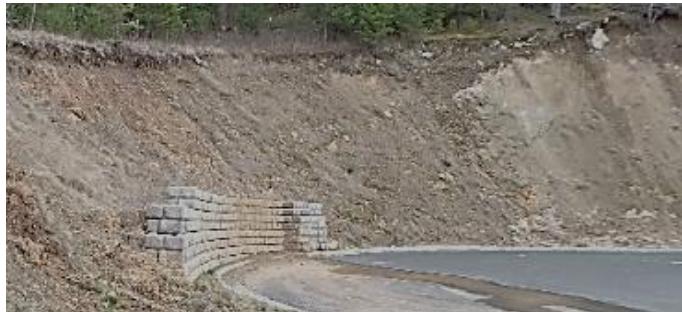
April, 2015 Dry Year

2015 Water was noted seeping from one point through the base of the wall.

The slope above the wall appeared relatively stable.

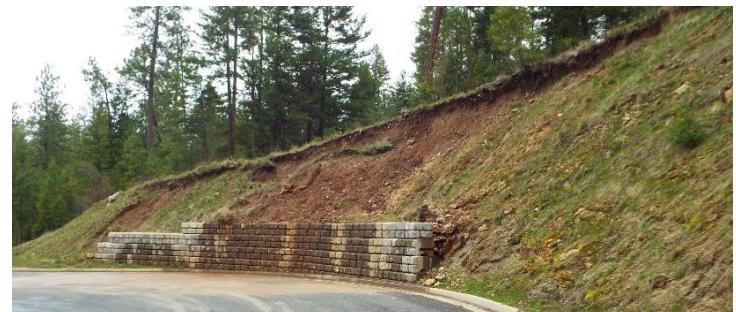
April, 2017 Wet Year

2017 Muddy water was noted seeping through much of the base of the wall. Most of the wall was wet suggesting that water had been running over the top.

Portions of the crest have broken away and are beginning to slide on to the wall.

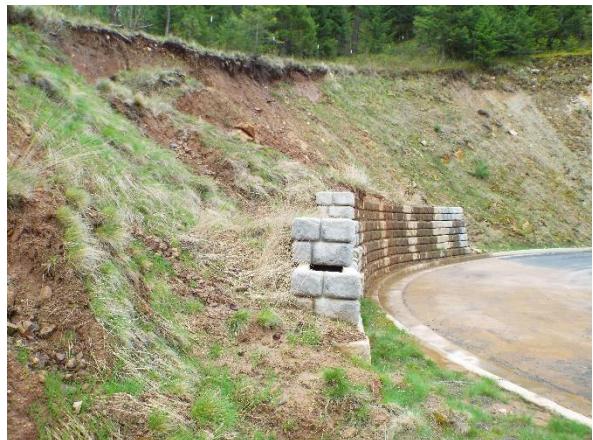
In this wet season of a wet year, the weight of water increased driving forces and reduced soil strength which upset the tenuous balance, resulting in small arcuate failures at the crest.

Permanent repair would require 1) either raising the wall or stabilizing the cut slope and 2) improving surface and subsurface drainage. This can be done by in one or more of several ways:

- **Raising the Wall.** Increasing the wall height would involve a complete rebuild. As the wall loads are proportional to the square of the height, longer geogrid reinforcing would be required from bottom to top.
- **Grading.** The upper portion of the cut slope slope could be graded back to a safe angle. This could be done with a backhoe from the top. If no property is available for this, soil nailing could be used to stabilize the existing slope above the wall. The slumped soil may need to be removed as the soil may be too loose to nail in-place.
- **Surface Drain.** The existing drainage swale could be redirected to the culvert to the north.
- **Subdrain.** Assuming the wall is rebuilt in order to raise it, a gravel drainage blanket could be installed behind the wall and the intercepted water piped to the culvert to the north.

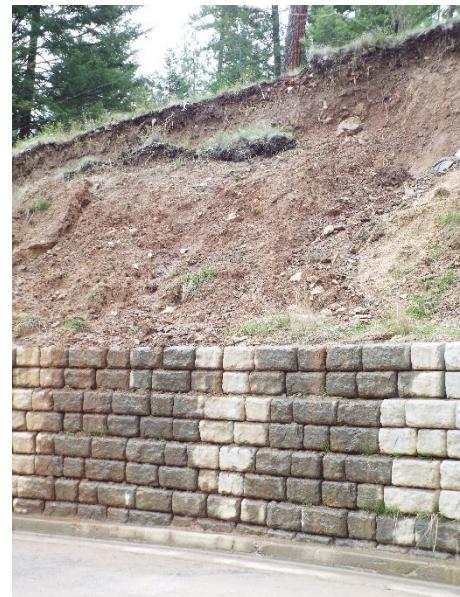
It appears that mud had been removed from the pavement.

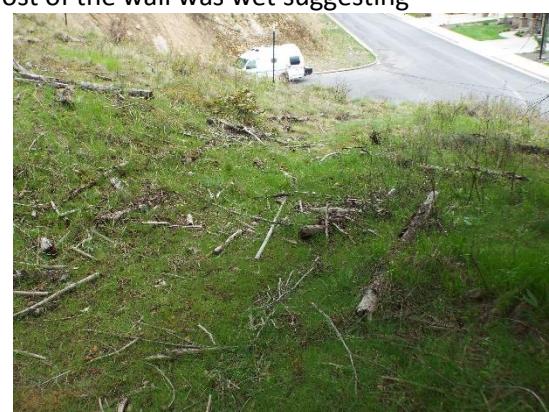
Above the crest, a small drainage swale channels surface runoff and snowmelt over the cut slope.
