Project S14514

PROJECT: Copper Canyon Lane, Wandermere Estates, Spokane, WA

SUBJECT: Reconnaissance and evaluation of existing rock cuts

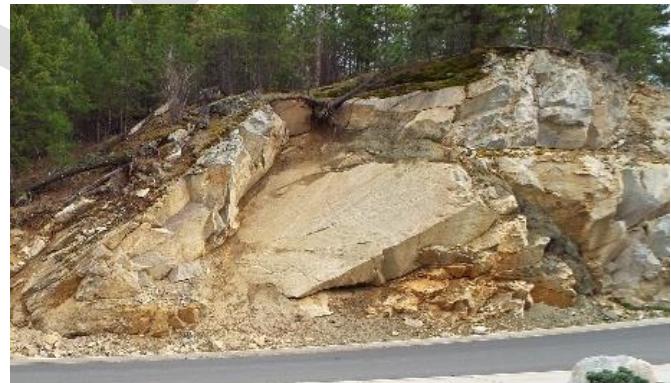
Prior to the Laramide Orogeny (*60 million years ago*), pre-Cambrian (*600 million years ago*) sediments dominated the entire area around Spokane. Then, in an episode of mountain building, the area was intruded by semi-molten granite of the Idaho Batholith which uplifted the area, fused the sediments, and in some cases melted the sediments to be re-solidified. Later erosion has removed the overlying metamorphosed sediment from this site leaving the granite exposed. In some areas, the bedding planes of the older sediments are still visible. (right)

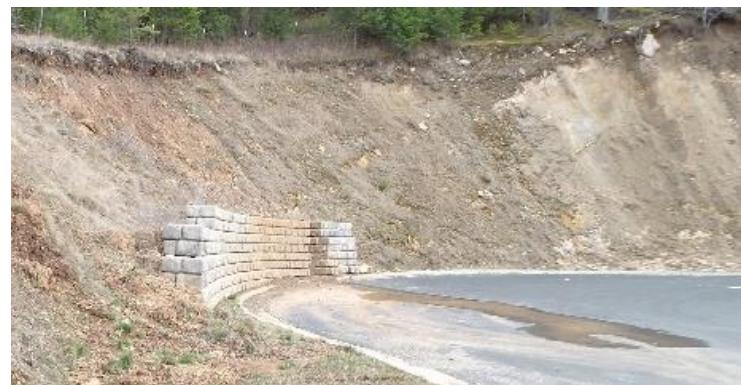
The surface soils overlying the granite and predominating in the area across from Lot 14, Block #1, comprise silty sands weathering from the decomposing granite. The material is moderately well-graded and sub angular, giving it relatively high strength.

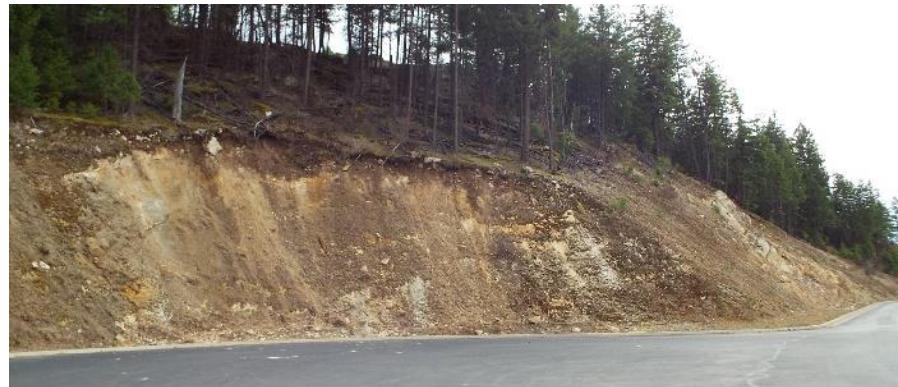
Our visit found evidence of minor rock fall from relatively stable rock cuts. The granite displays numerous fractures and fissures with the potential for more serious rockfalls. The soil cut at the center cu-de-sac has raveled back to its repose angle $1\frac{1}{2}$ horizontal to 1 vertical and, as such, has no margin of safety against deep-seated slope failure. (right)

- **Soil Cut Slope Stability.** The cut slope at the center cul-de-sac should be stabilized with a toe surcharge to increase resisting forces. This can be accomplished by simply extending the existing Redi-Rock retaining wall around the rest of the cul-de-sac and backfilling it. Where it will not interfere with neighboring property, backfill material should be taken from the crest of the slope so as to reduce the driving forces.

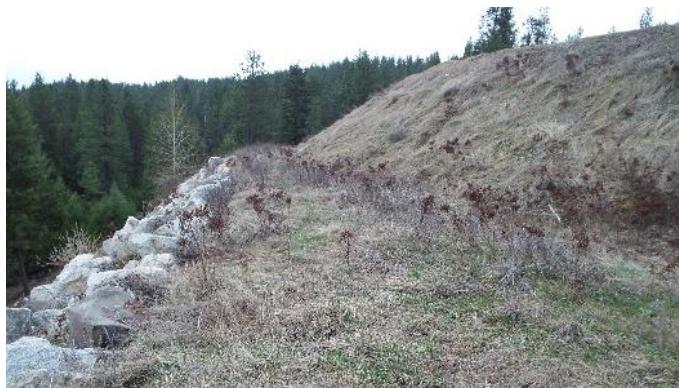
Lots 26, 27, & 28, Block #1, at the cul-de-sac end, are on a newer fill over an older slope protected by rip rap. (left)

- **Fill Slope Stability.** The entire slope (*new and old*) behind Lots 26, 27, and 28, Block #1, at the end cul-de-sac should be analyzed for stability, and remediated as may be necessary.

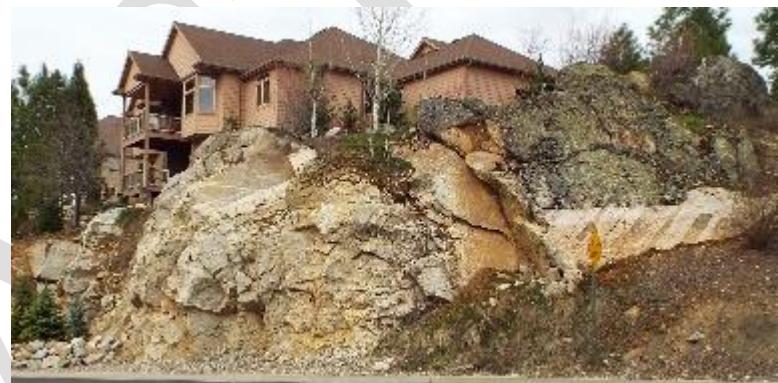
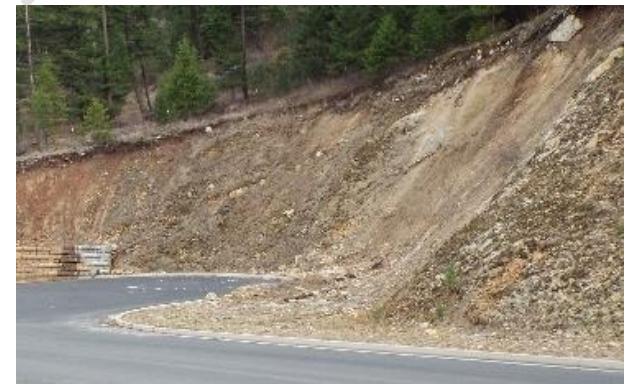
- ❖ **Rock Cut Slope Stability.** Although fractured and fissured, the rock cuts appear quite sound, and are not likely to experience deep-seated slope failures. (right)
- ❖ **Soil Cut Slope Stability.** The cut slope at the center cul-de-sac is at its repose angle with a sf of 1.0. As such, it is likely to fail and take out a portion of the pavement. It is not likely to threaten homes on Lots 14, in either Block #1 or Block #9, but the head scarp will probably infringe on the neighboring property to the east. (mid-right)
- ❖ **Major Rock Fall.** There is the possibility that large segments of granite could slide or break loose on existing fractures or fissures and fall onto the road. This would probably be triggered by water freezing in the fissures, and most likely would show evidence of movement before a fall. (lower-right)

- **Rock Cut Slope Stability.** Although the rock cuts appear quite sound, they should be monitored for unlikely signs of mass movement.
