Project S17206

## Memorandum

**Project: North Wandermere Estates Lane, Spokane, WA**  
**Subject: Results of Limited Geotechnical Evaluation**

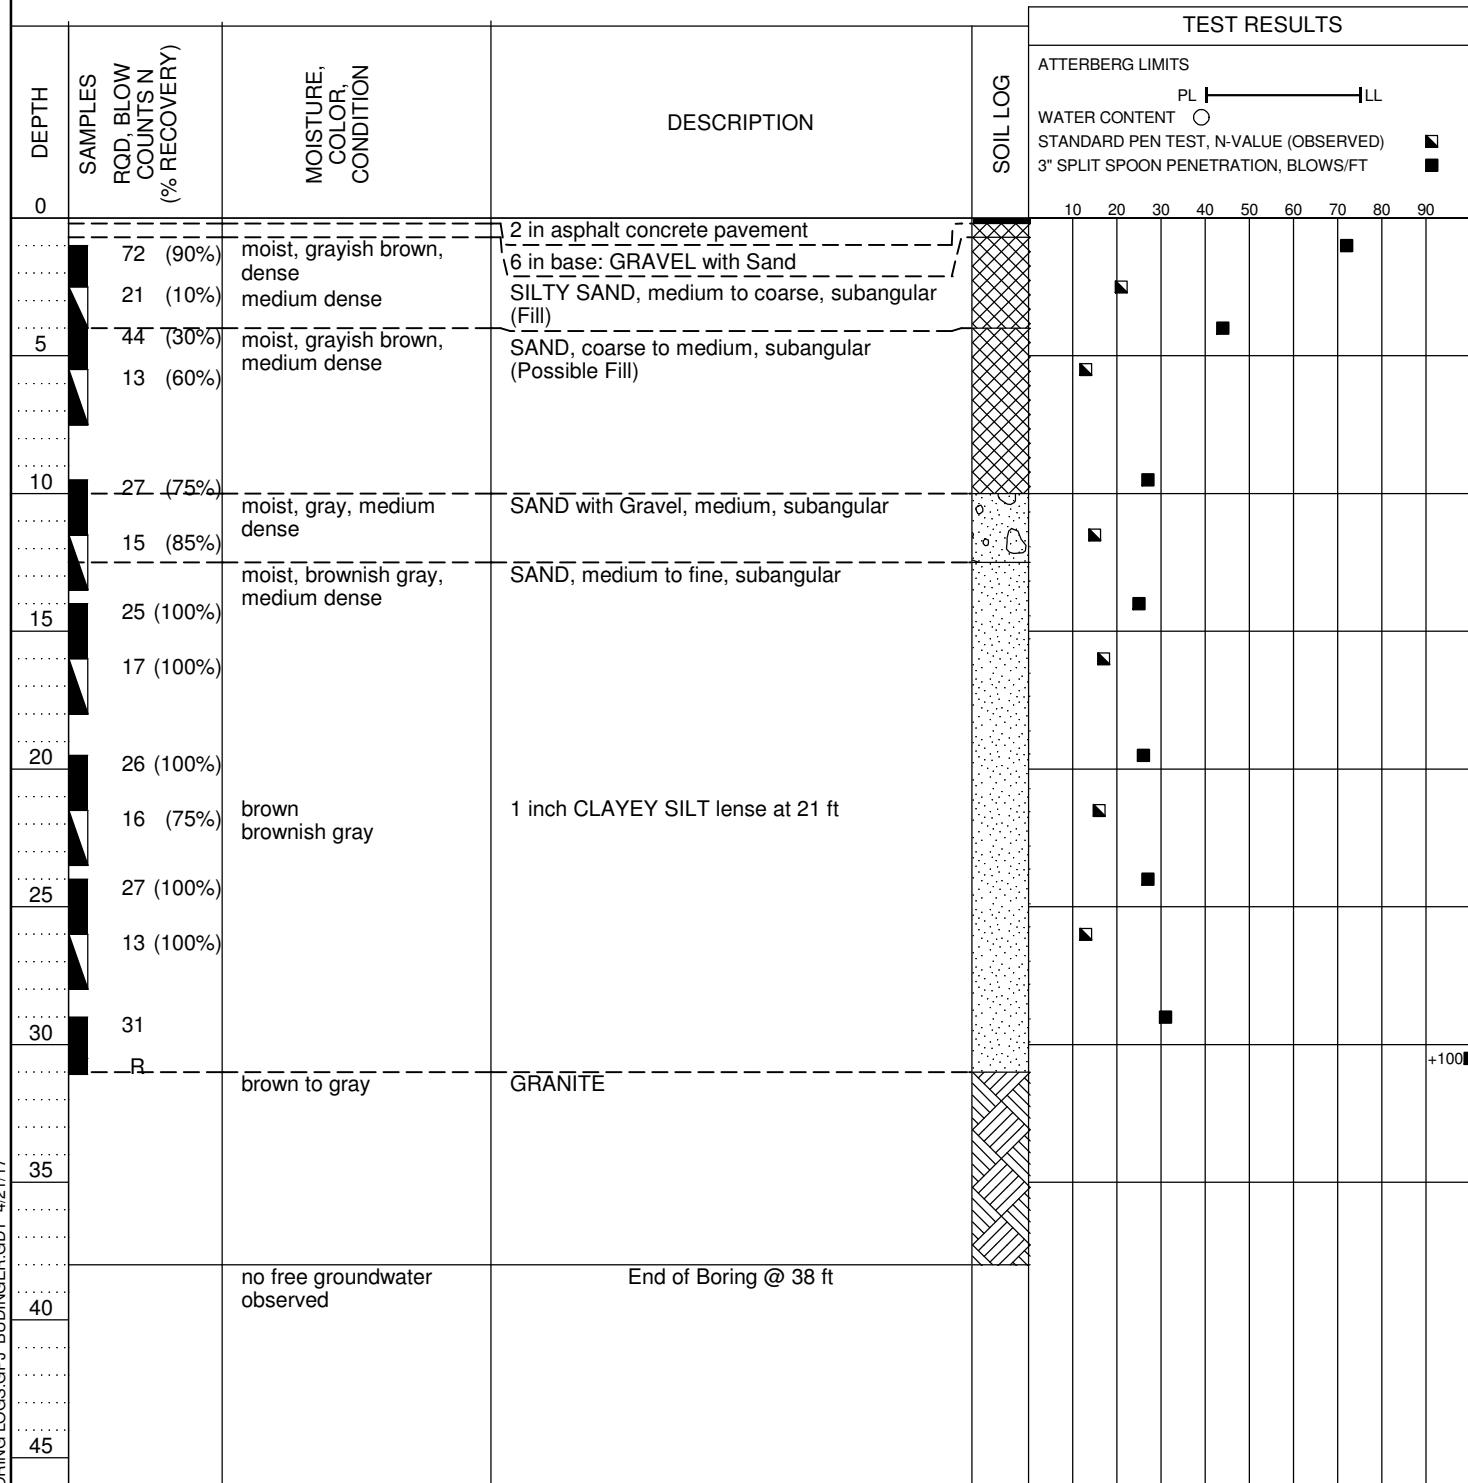
## TEST BORING 4

One thin (1inch) layer of *Silty Clay* was recovered in Boring 4 at 21 feet. Because it was so thin, this layer may not have been detected in the other borings where there were drilling intervals with no sampling. The significance of this layer, if present across the site, is that it could be a layer on which future land-sliding might occur.

We did not observe subsurface conditions that would indicate current instability of the road and its underlying infrastructure. The presence of the thin clayey silt layer in Boring B-4 could indicate that a similar layer under the lots is enabling the current land subsidence as the strength of this layer may be less than is necessary to support the slope inclination. This condition may explain one reason for the land

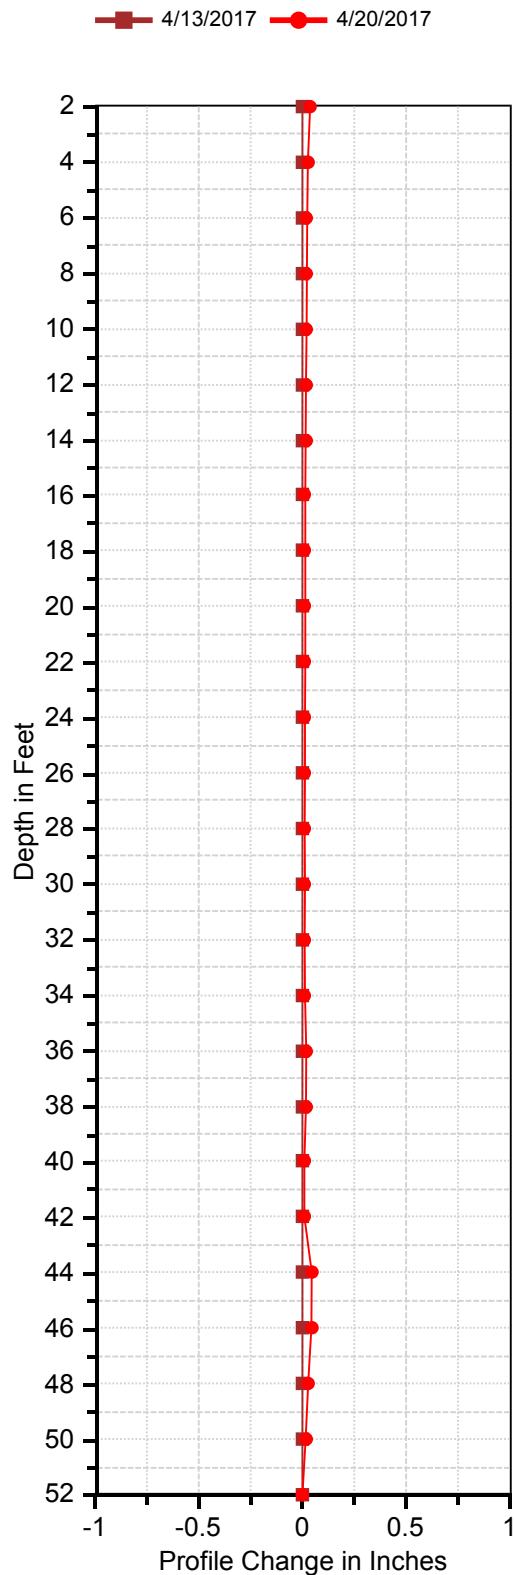
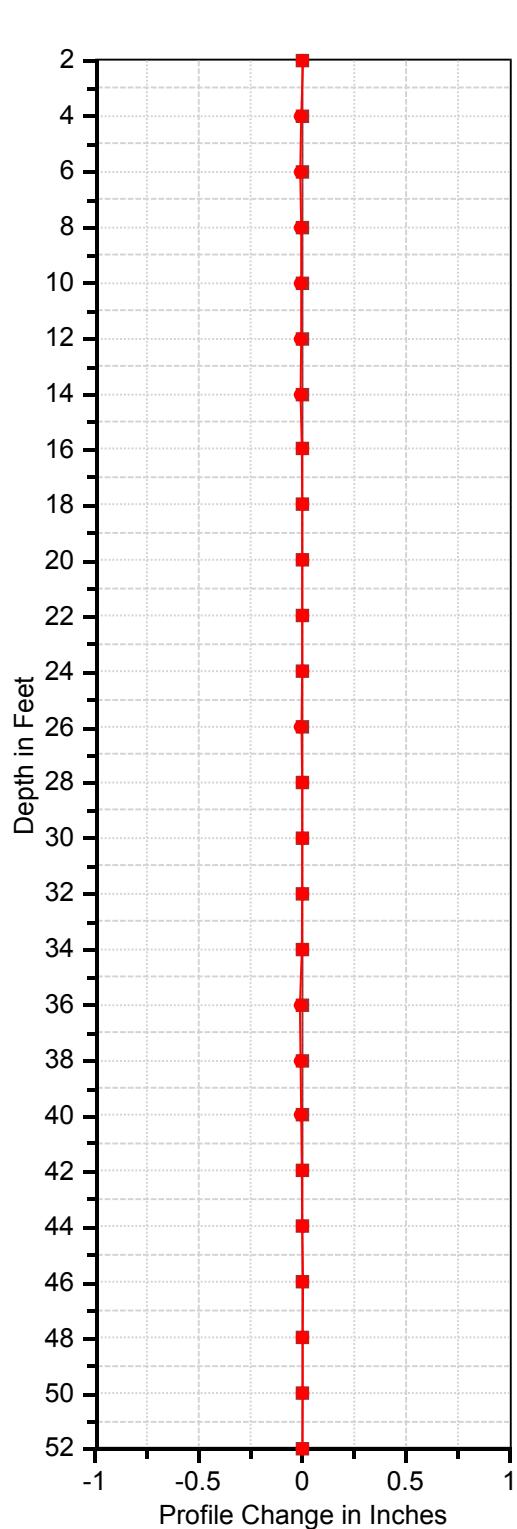
Our first reading was taken on April 14, 2017. We accomplished a second reading on April 20, 2017. No discernible movement occurred during that period.
