Location
Wandermere Estates HOA,
Spokane, WA

Photos Taken by:
Kenneth Pfaff, P.E.

Inspection Date:
November 9, 2016

CRITERIUM
PFAFF ENGINEERS®

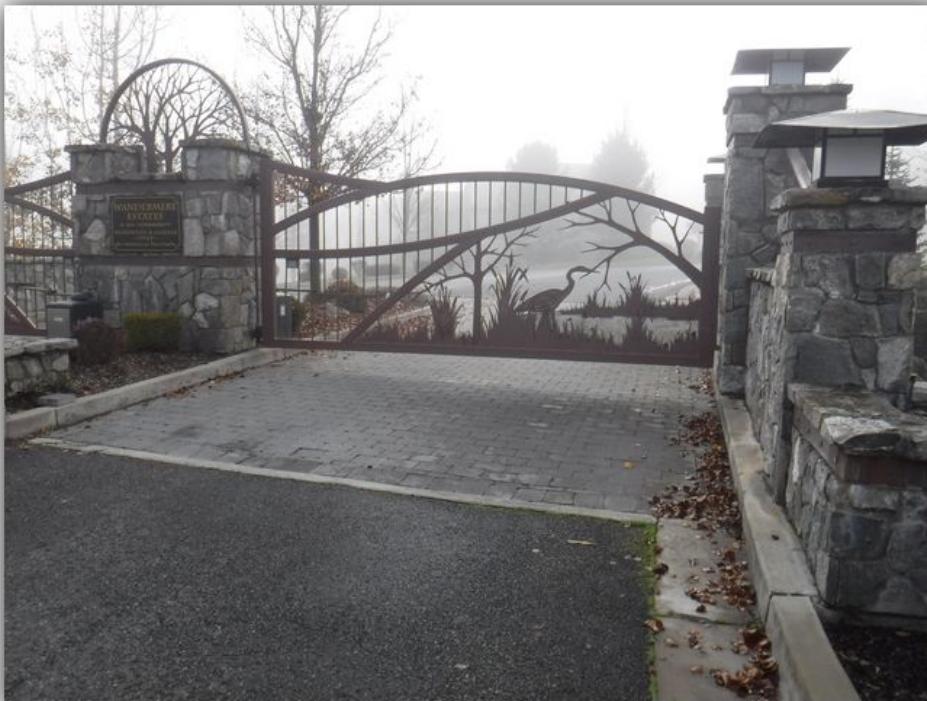
Photo Number
1

Description:
Lower entry monuments, gate, and bridge.

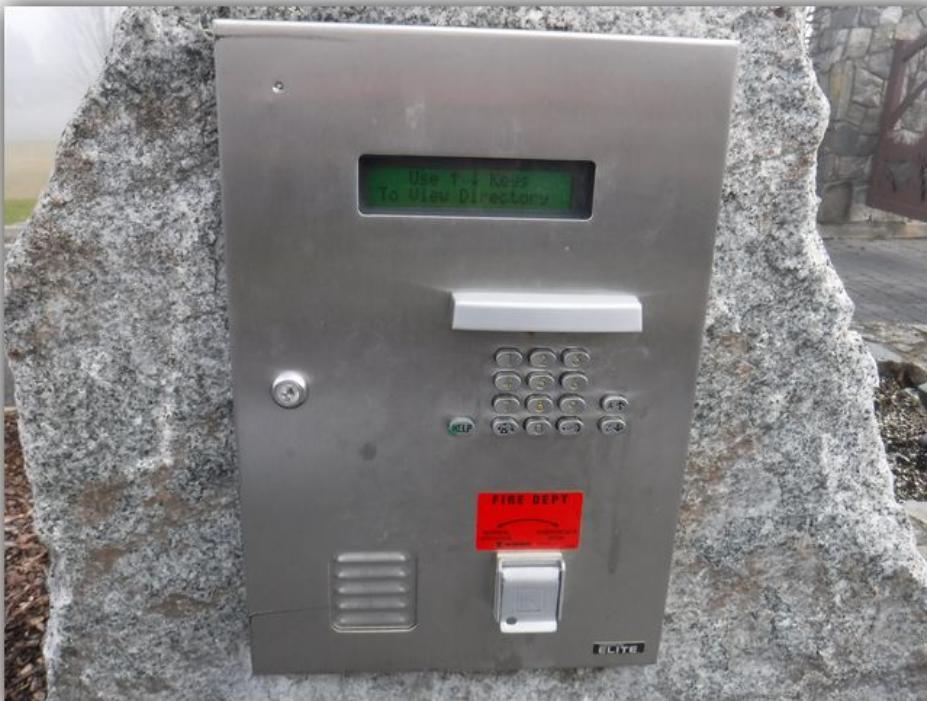
Photo Number
2

Description:
Entry call station

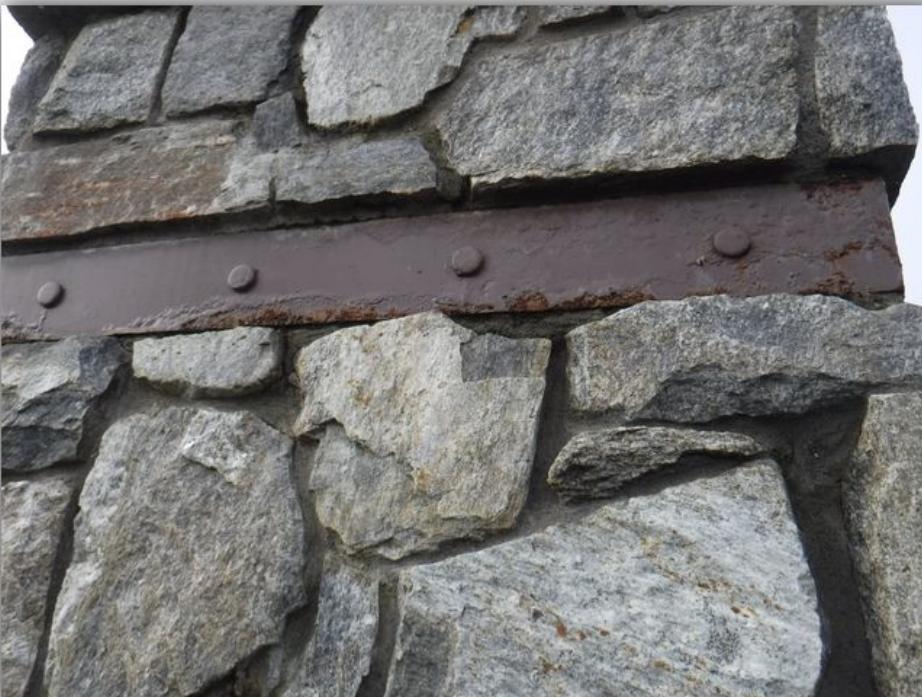
Photo Number
3

Description:
Corrosion on monument
decorative bands. Typical of
all.

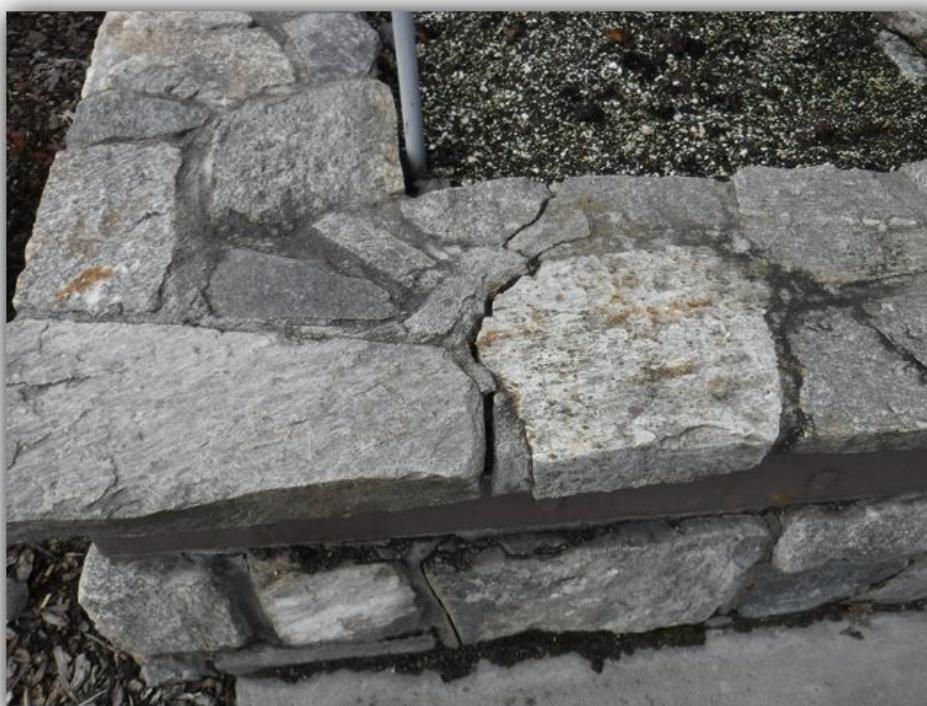
Photo Number
4

Description:
Loose and broken mortar at
monument.

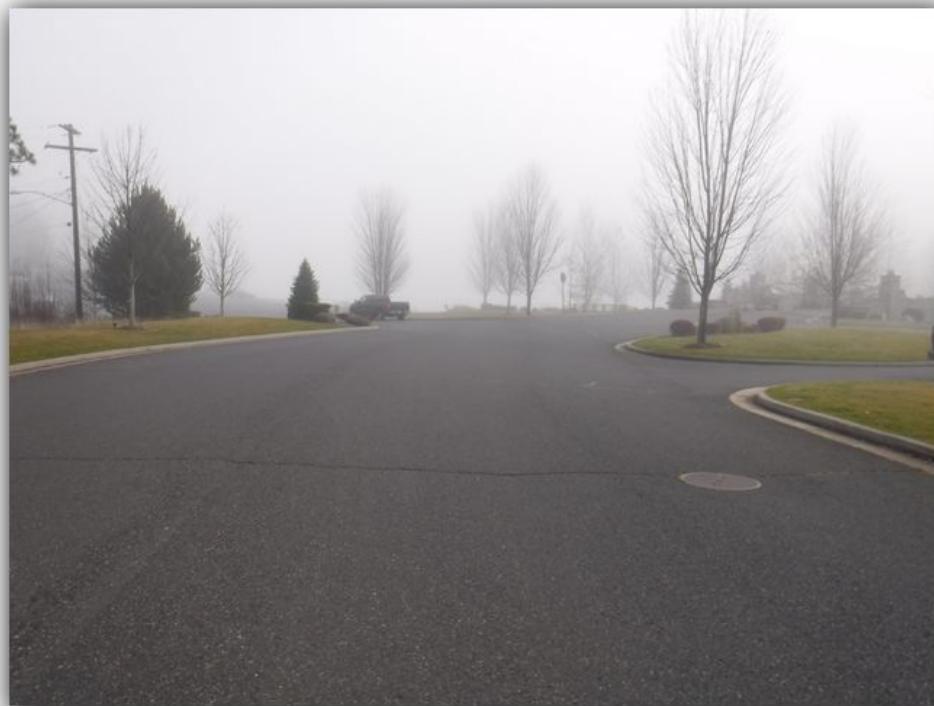
5

Entry asphalt. Note crack.

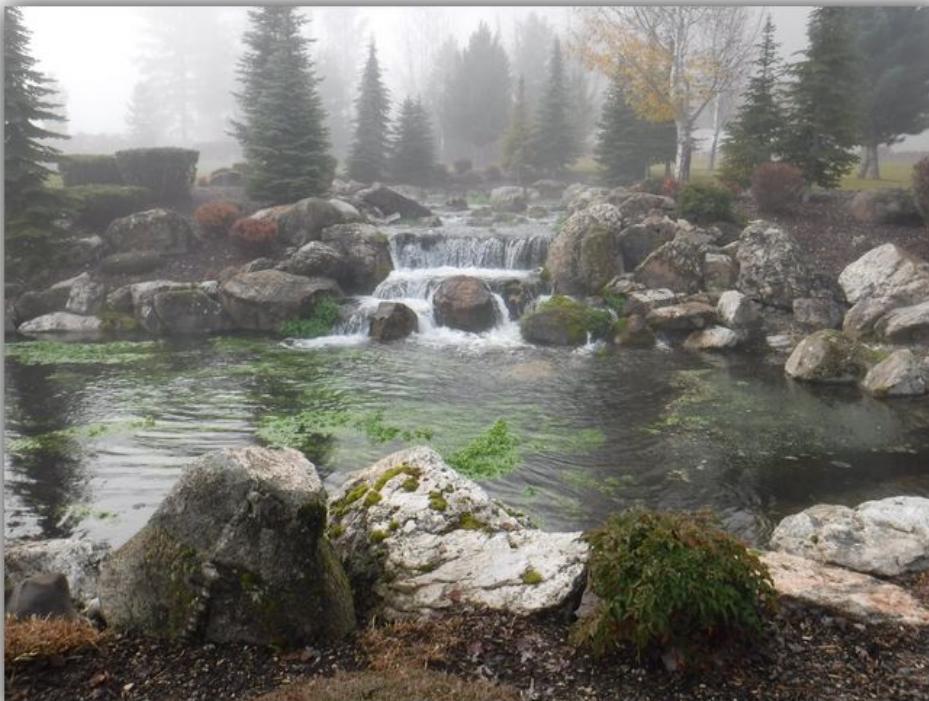
6

Entry stream/water feature.

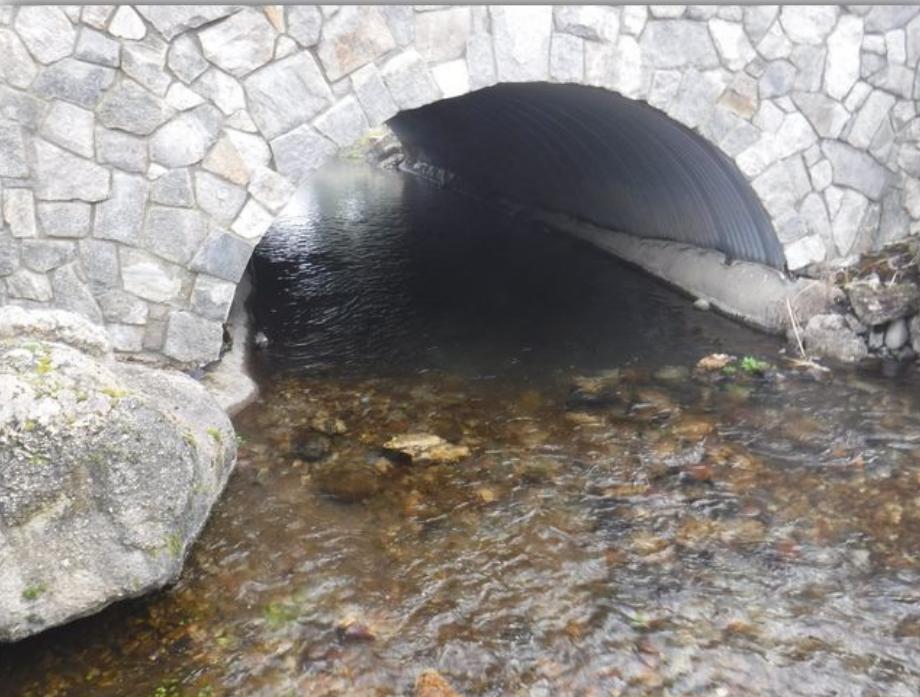
Photo Number
7

Description:
Culvert below bridge.

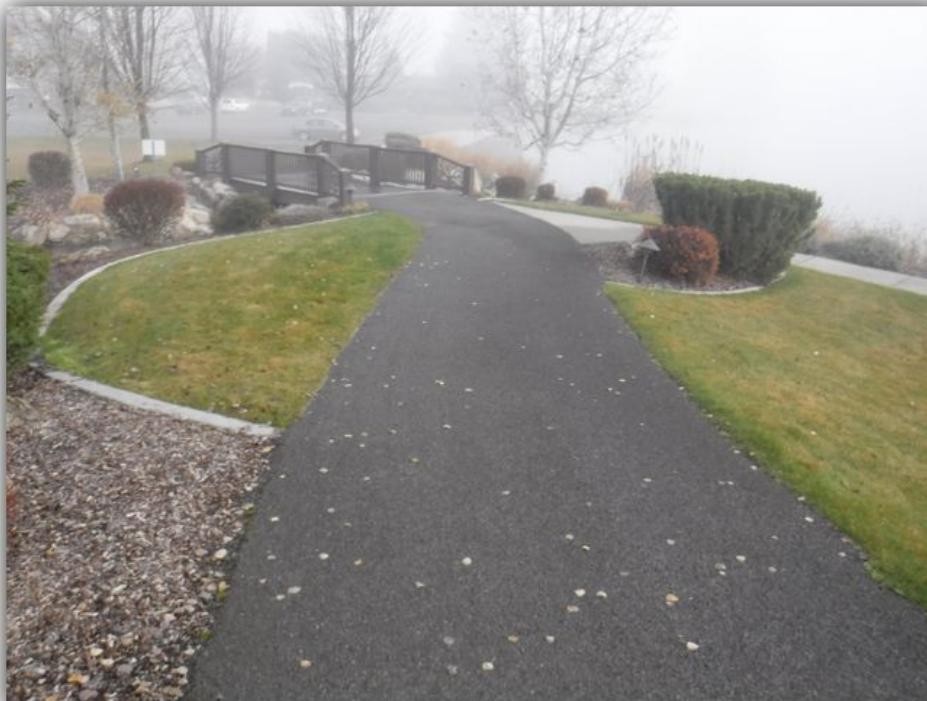
Photo Number
8

Description:
Path to golf course

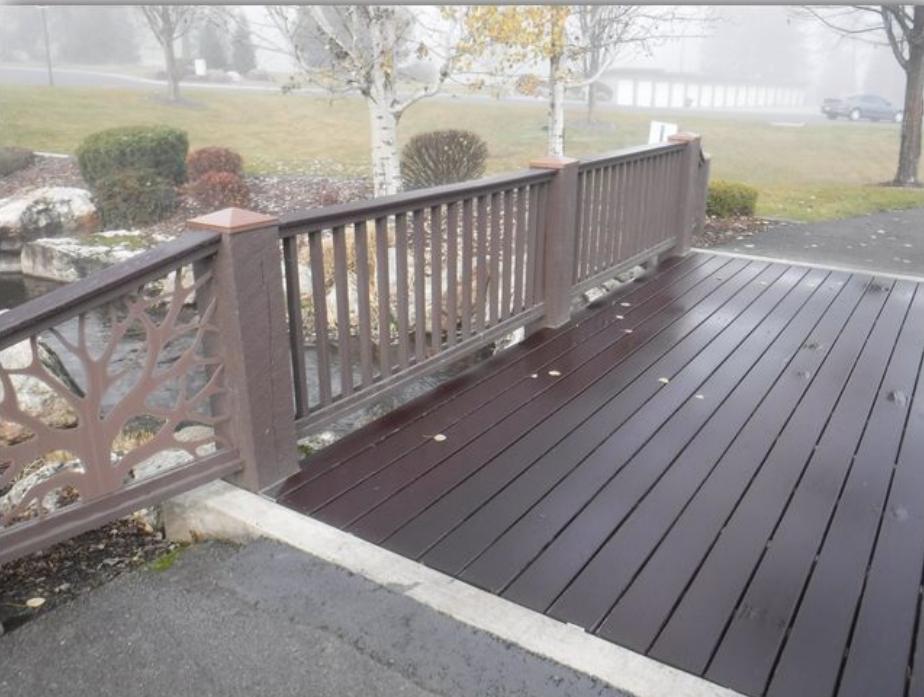
Photo Number
9

Description:
Golf path bridge

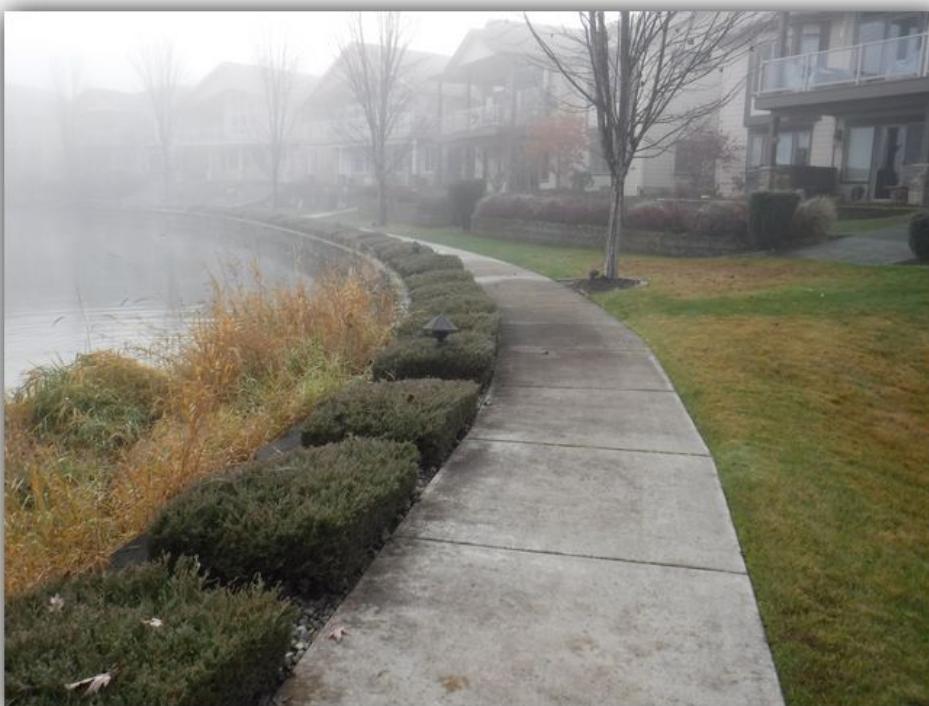
Photo Number
10

Description:
Sidewalk along lake

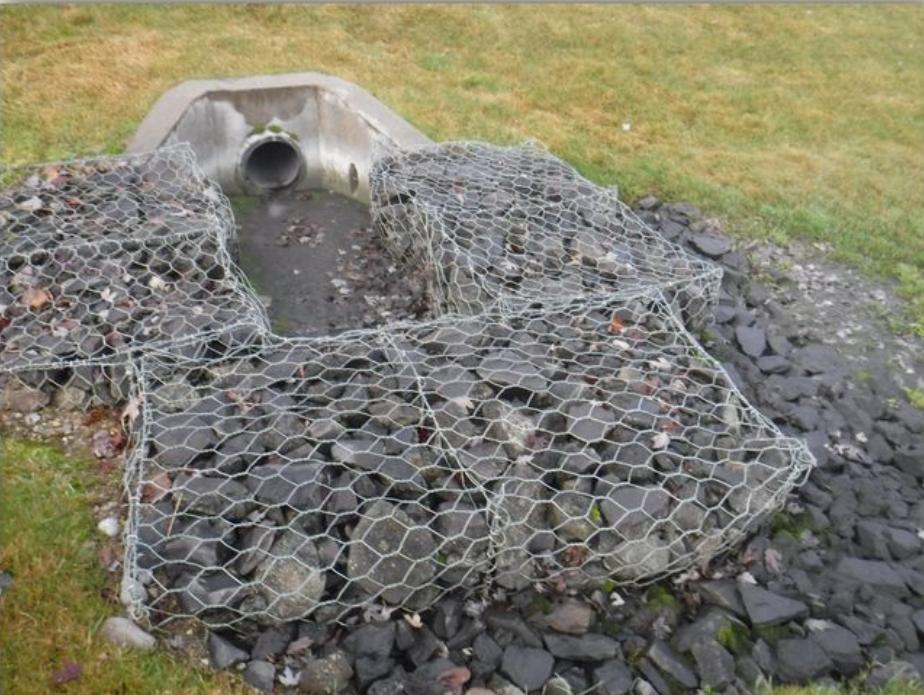
Photo Number
11

Description:
Lower swale with reported silting problem.

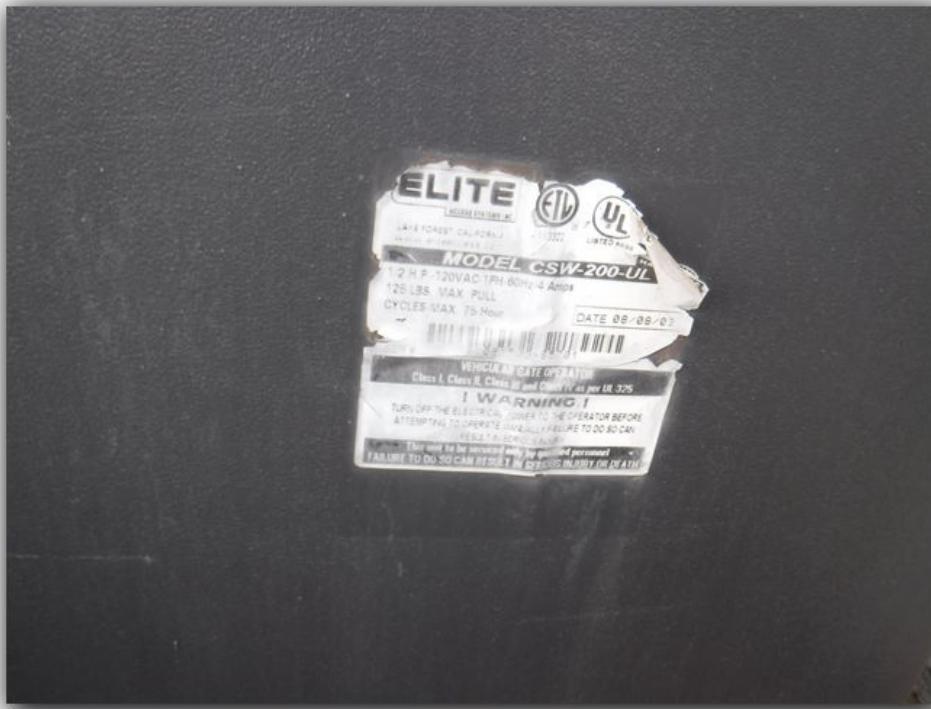
Photo Number
12

Description:
Gate operator tag

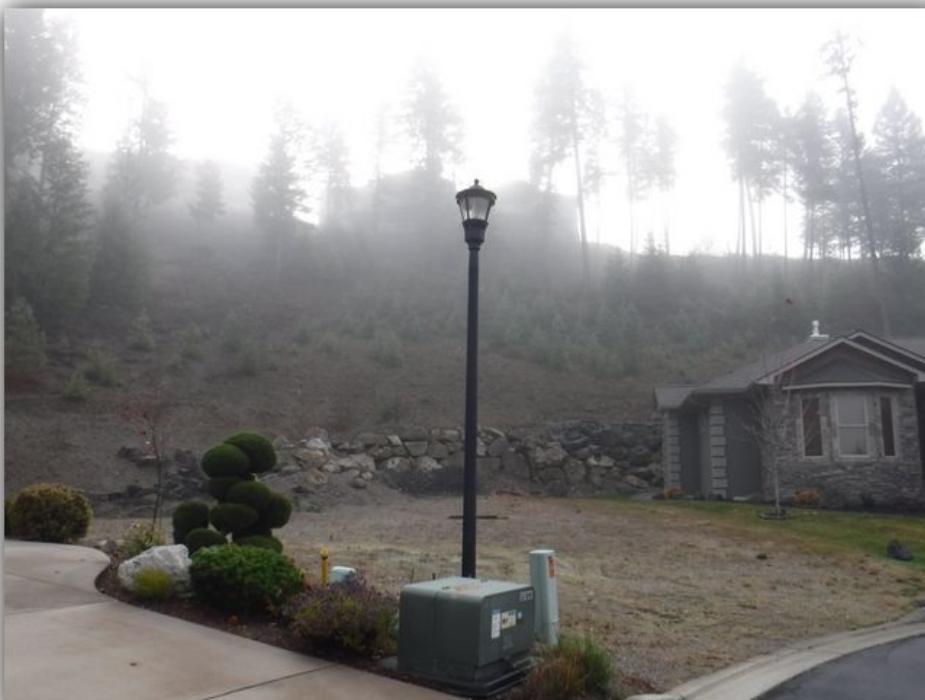
Photo Number
13

Description:
Typical street light pole.

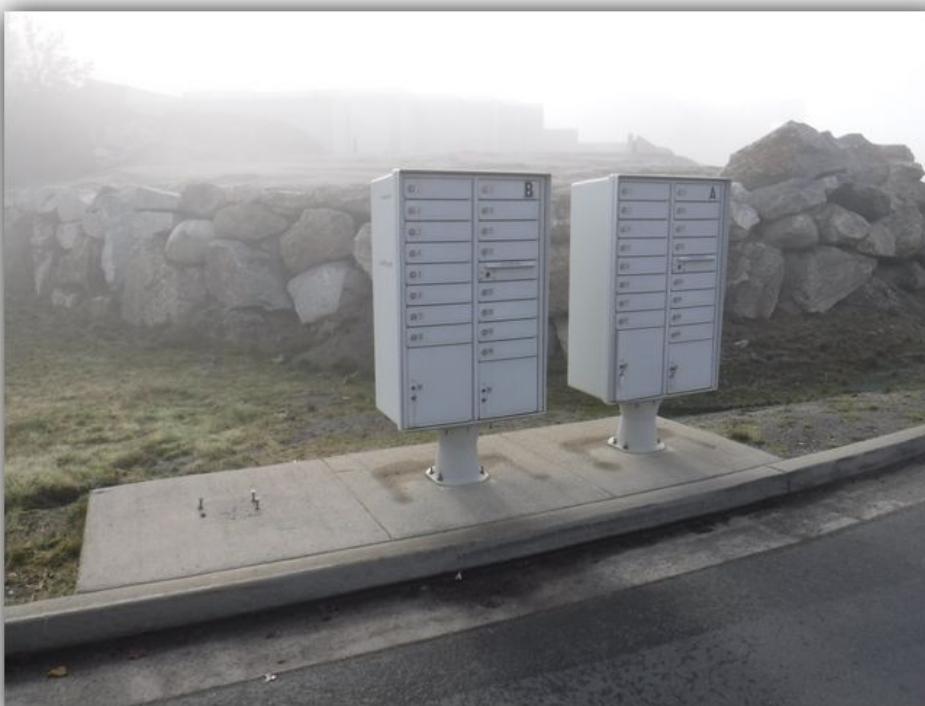
Photo Number
14

Description:
Typical mailboxes

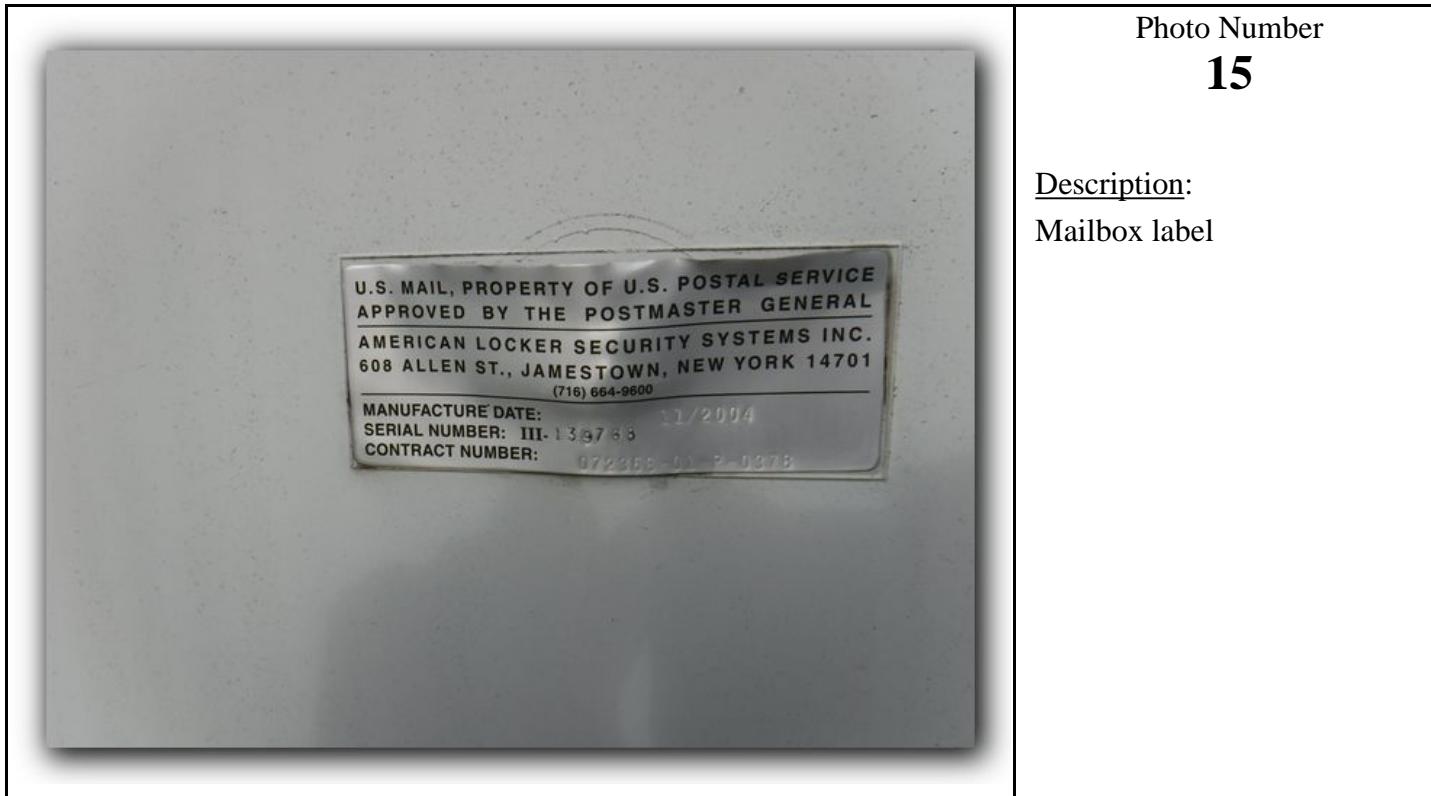
15

Mailbox label

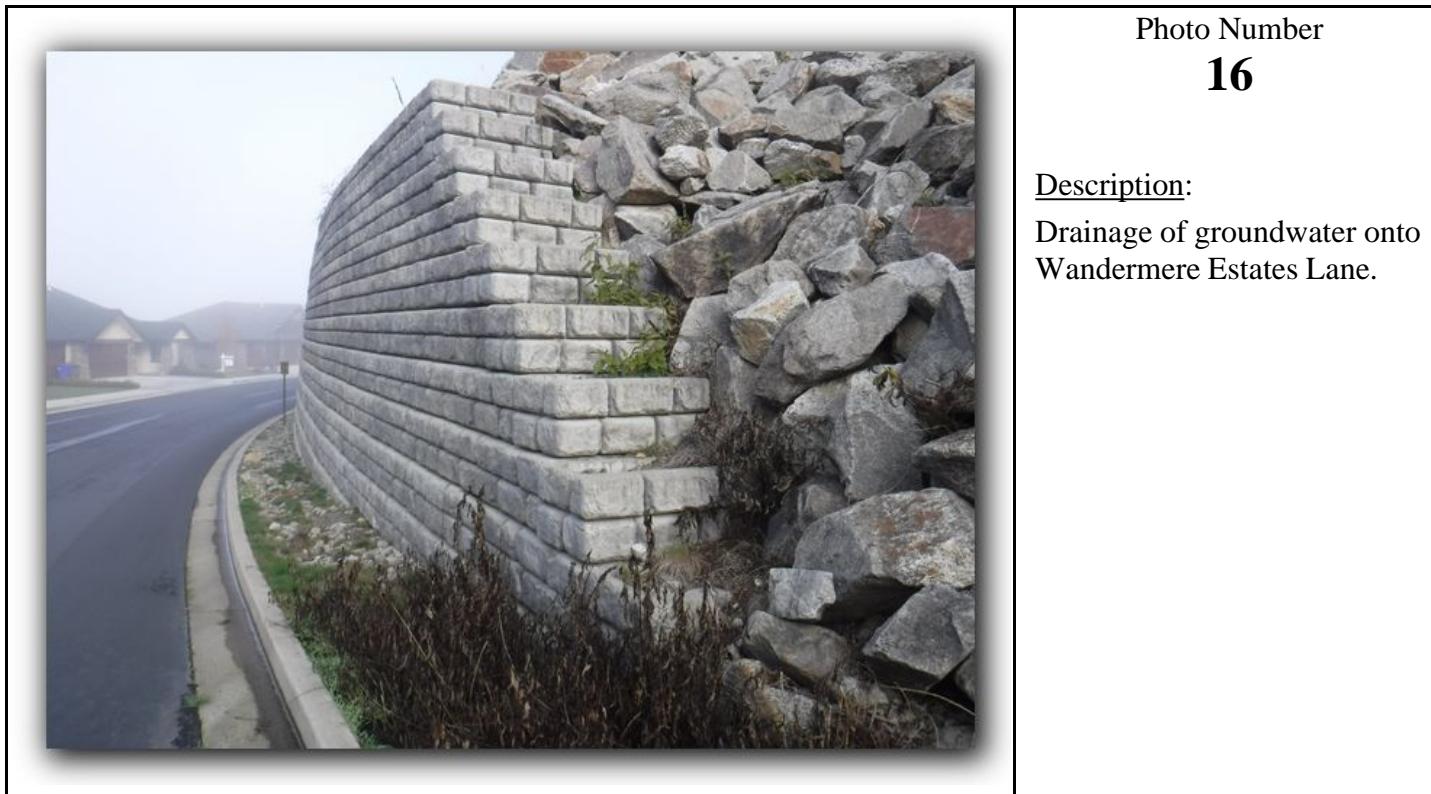
16

Drainage of groundwater onto
Wandermere Estates Lane.

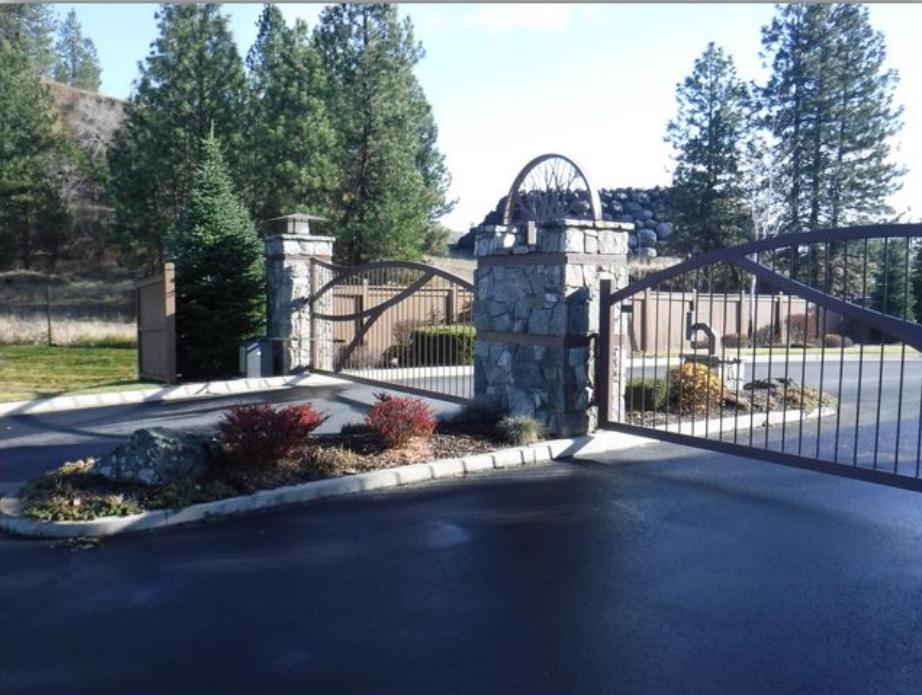
Photo Number
17

Description:
Upper monuments and gates

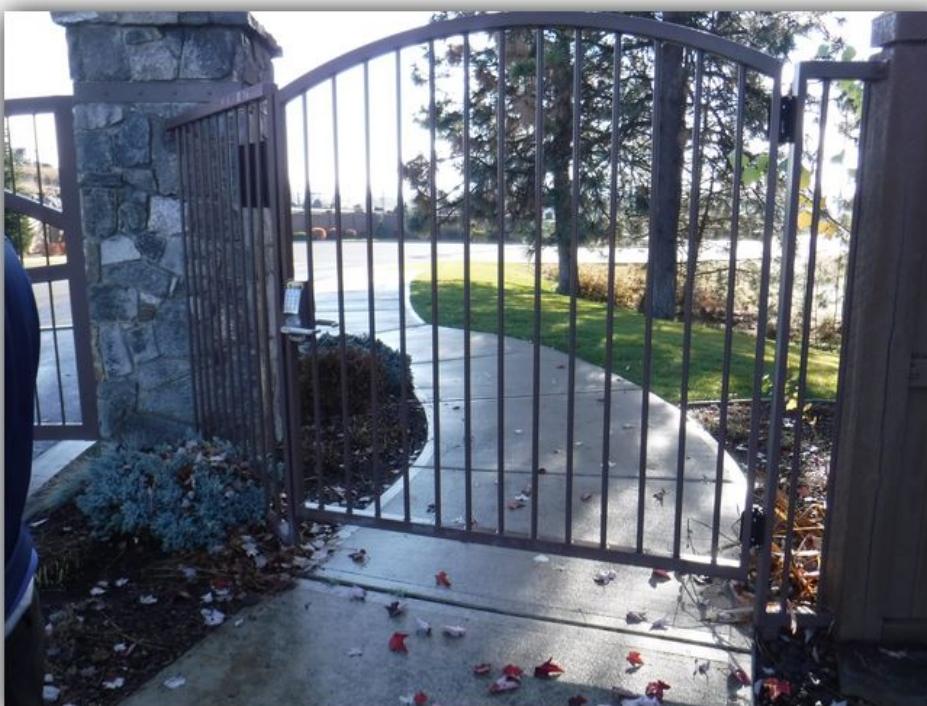
Photo Number
18

Description:
Upper pedestrian gate

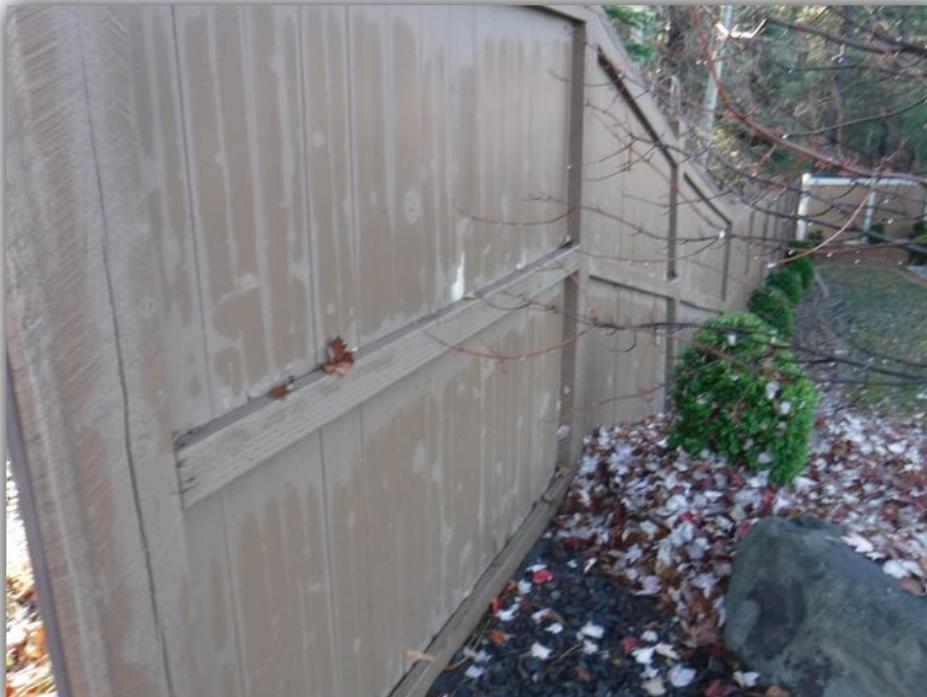
Photo Number
19

Description:
Upper wood fence

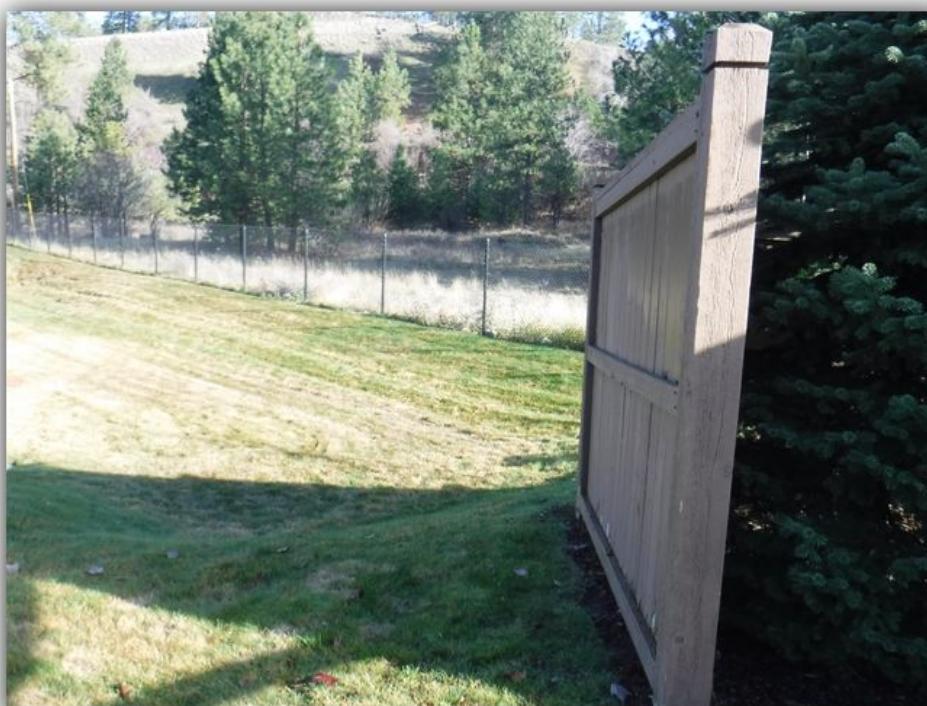
Photo Number
20

Description:
Upper wood and chain link fences.

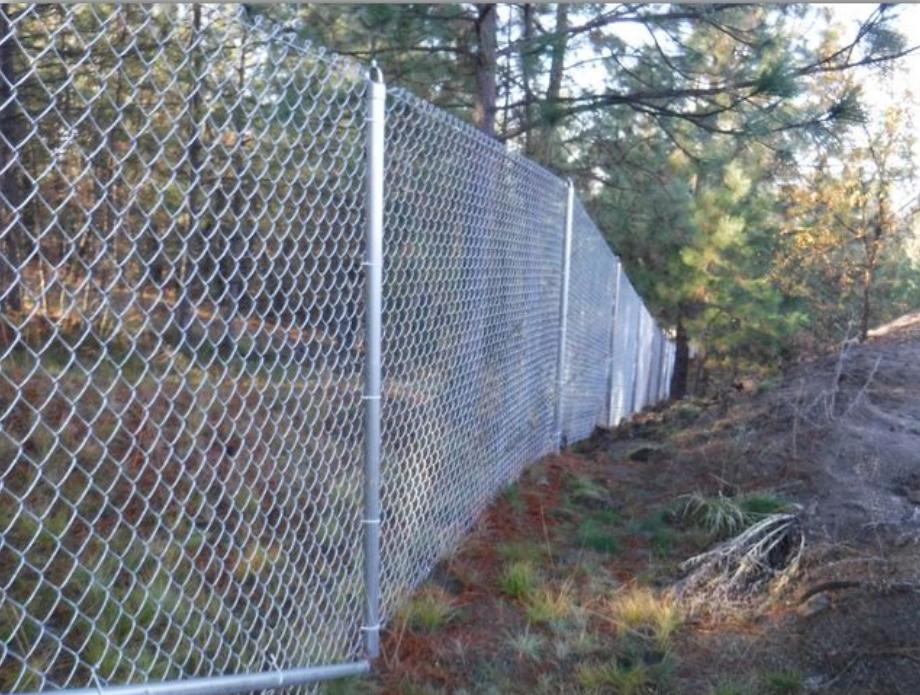
Photo Number
21

Description:
South chain link fence

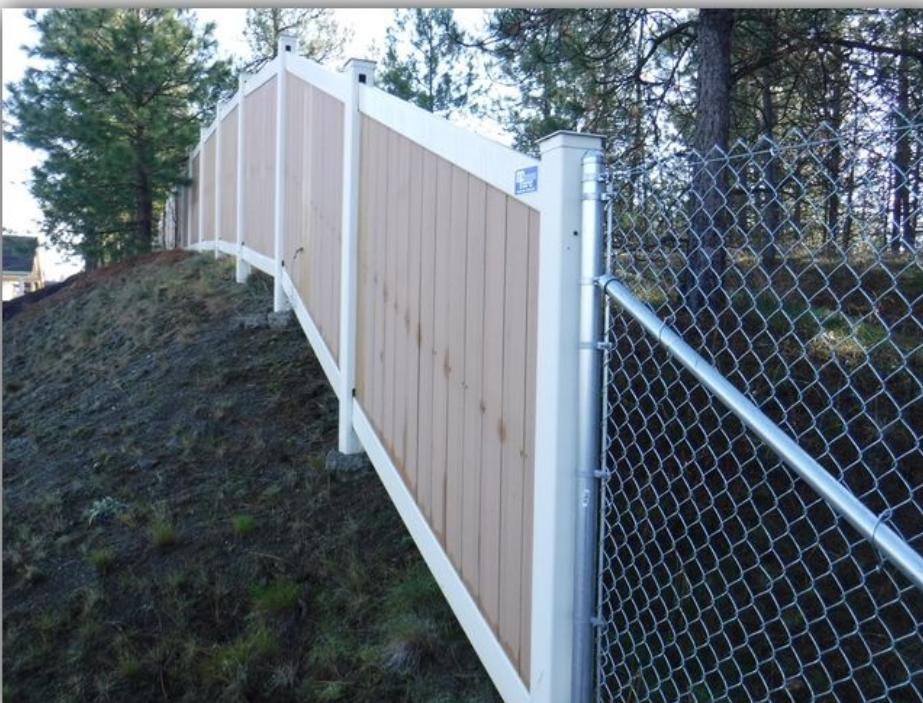
Photo Number
22

Description:
South vinyl and chain link fence

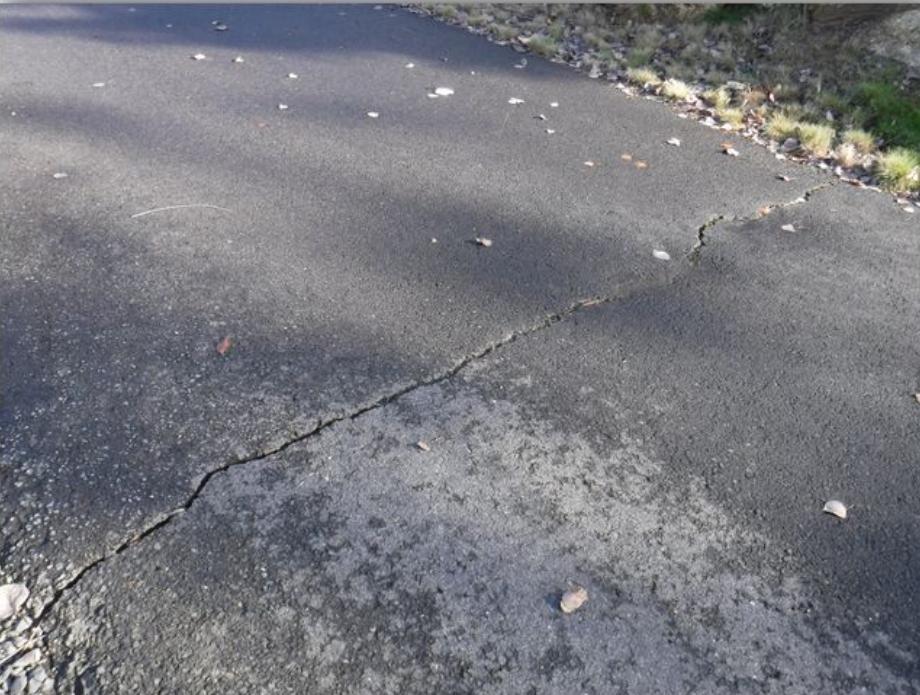
Photo Number
23

Description:
Pathway asphalt crack and sealcoating needed.

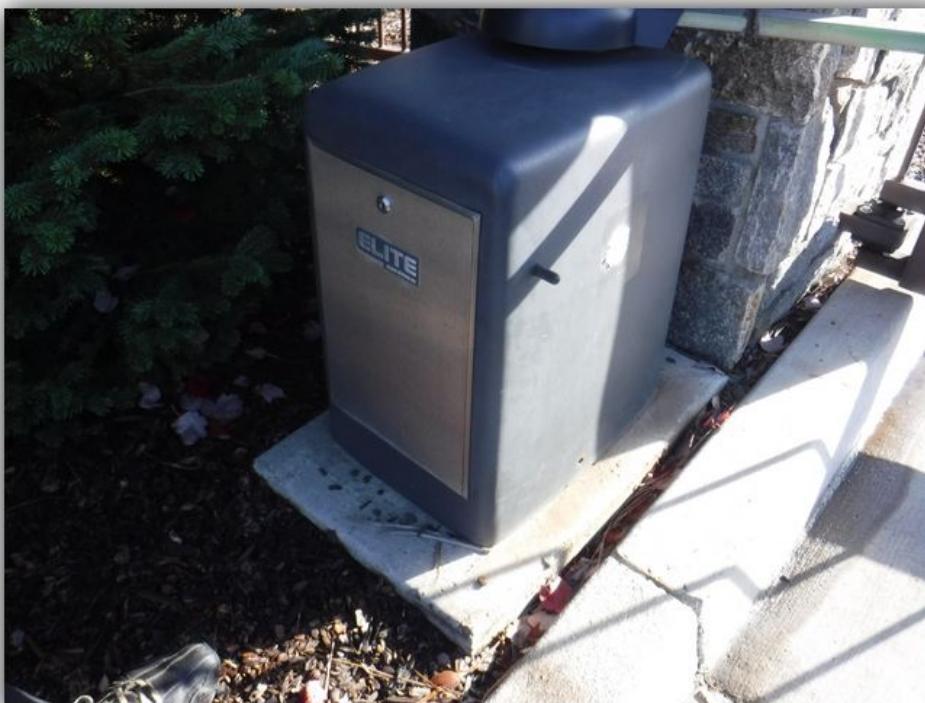
Photo Number
24

Description:
Gate operator
