Wandermere Estates HOA,
Spokane, Washington

Photos Taken by:
Kenneth Pfaff

Inspection Date:
August 12, 2020

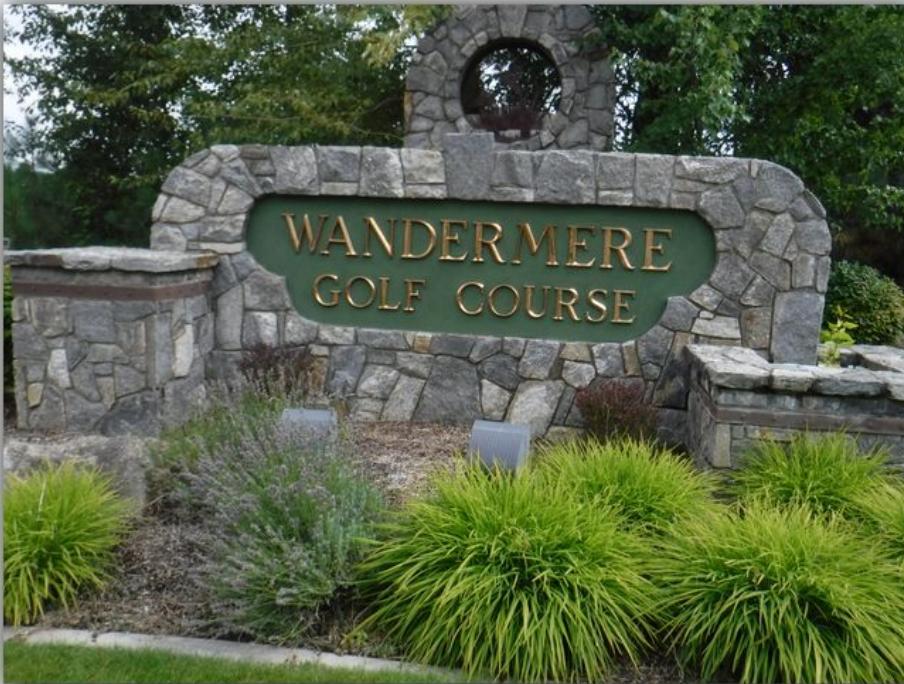
1

Entry monument

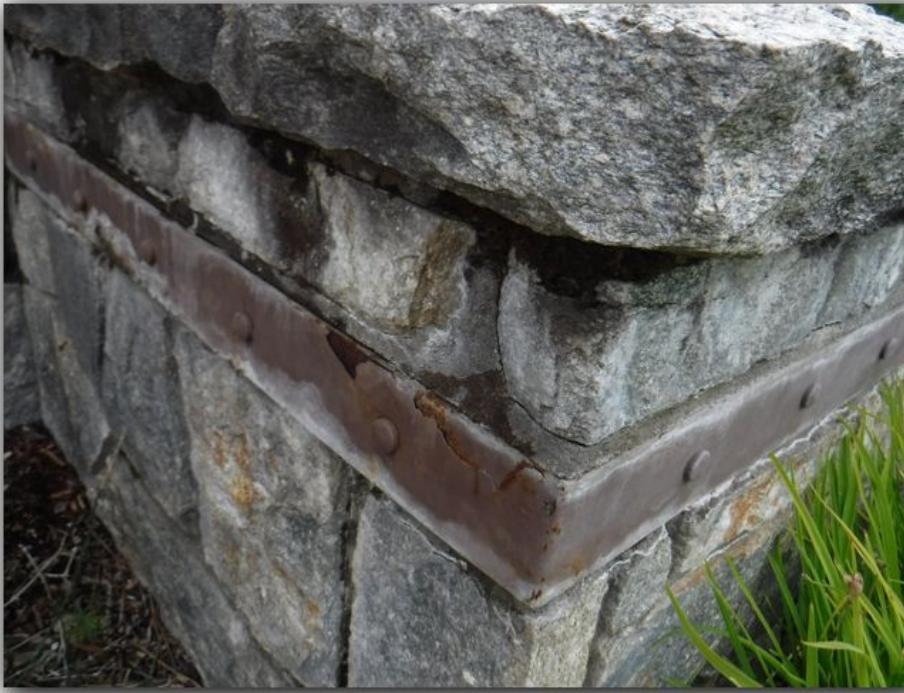
2

Corrosion of steel bands on
monument

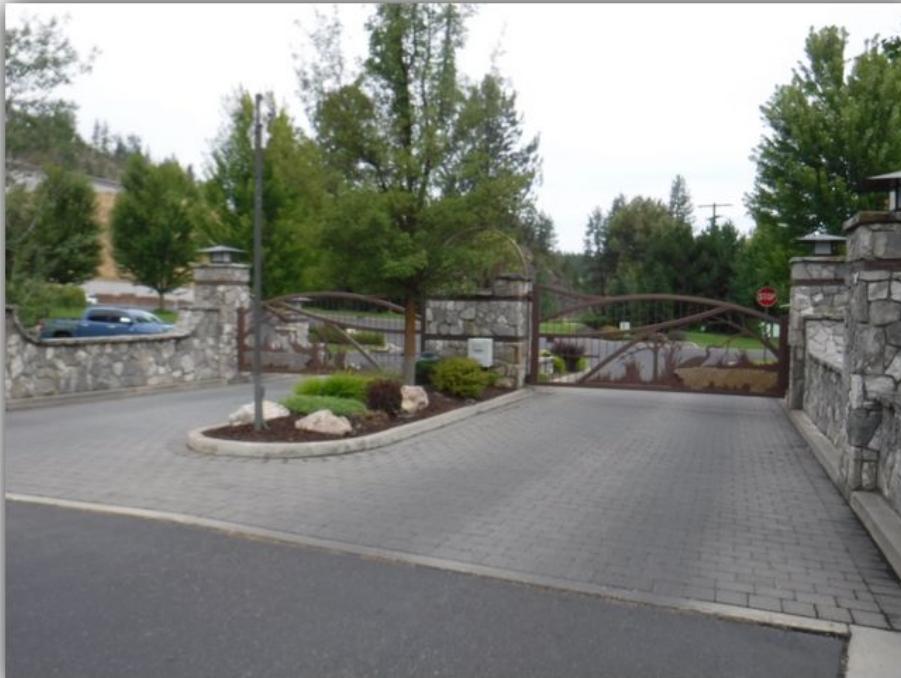
3

Lower entry

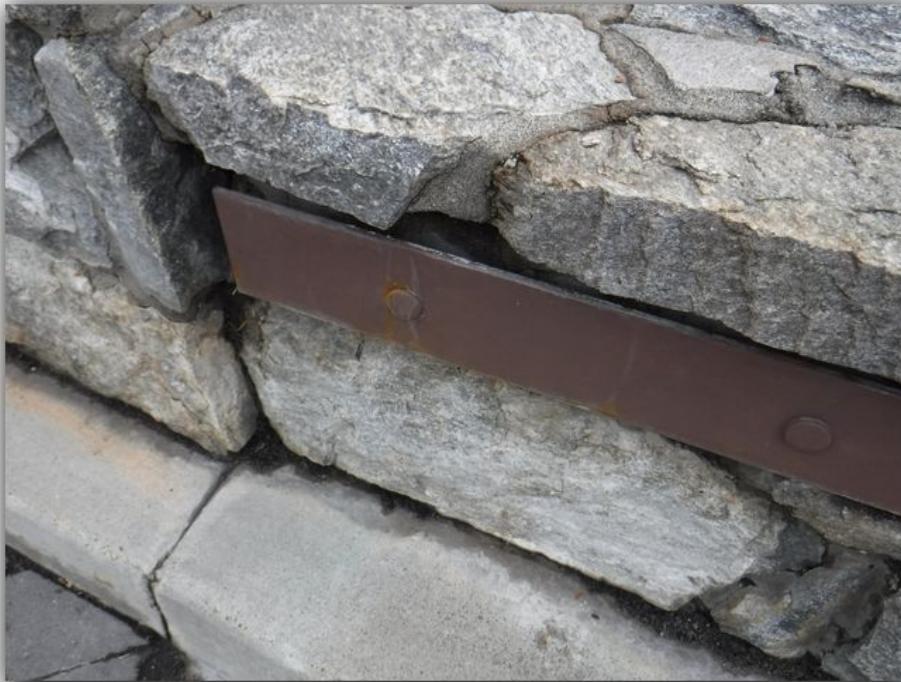
4

Loose steel band at entry-
typical of several areas

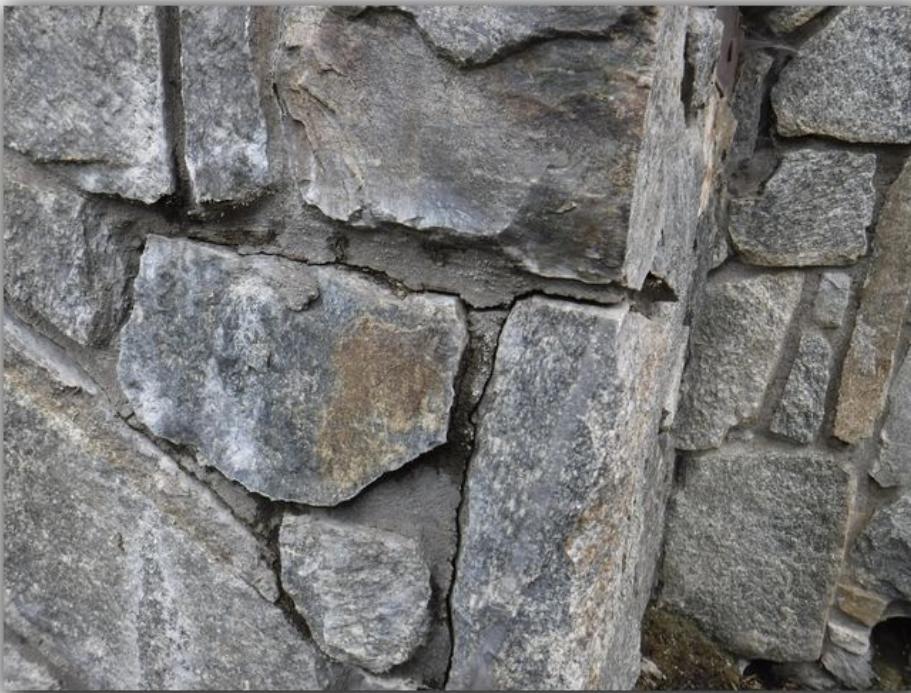
5

Cracked mortar in entry area
gate supports

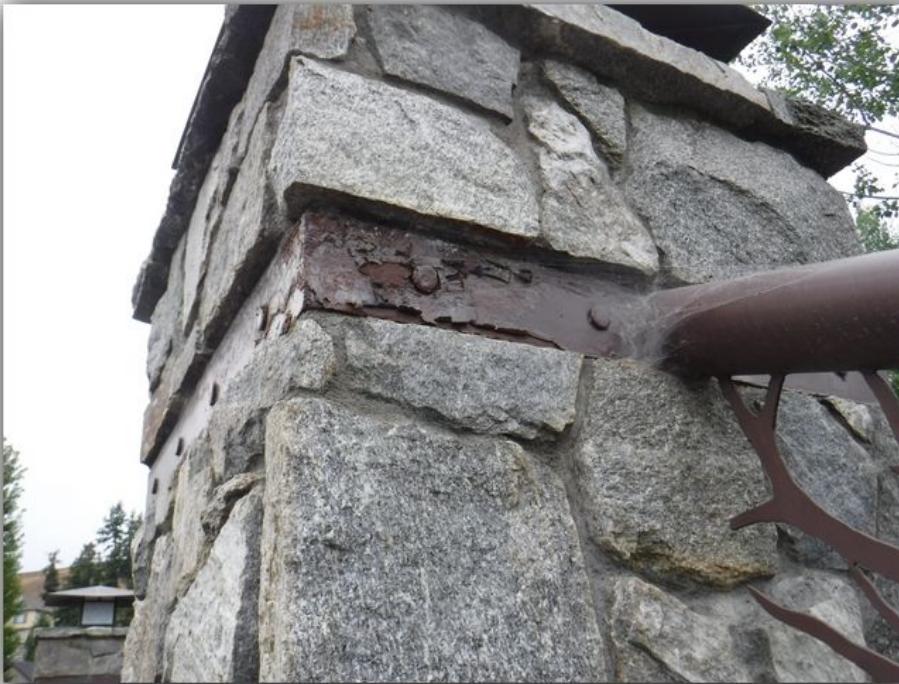
6

Corroded steel bands at entry
area

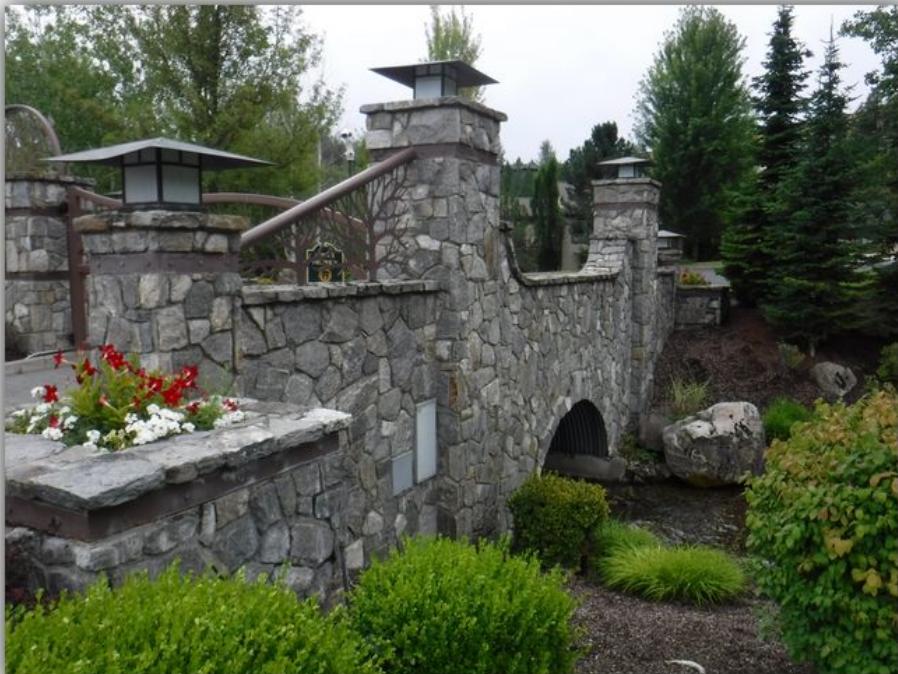
7

Entry bridge

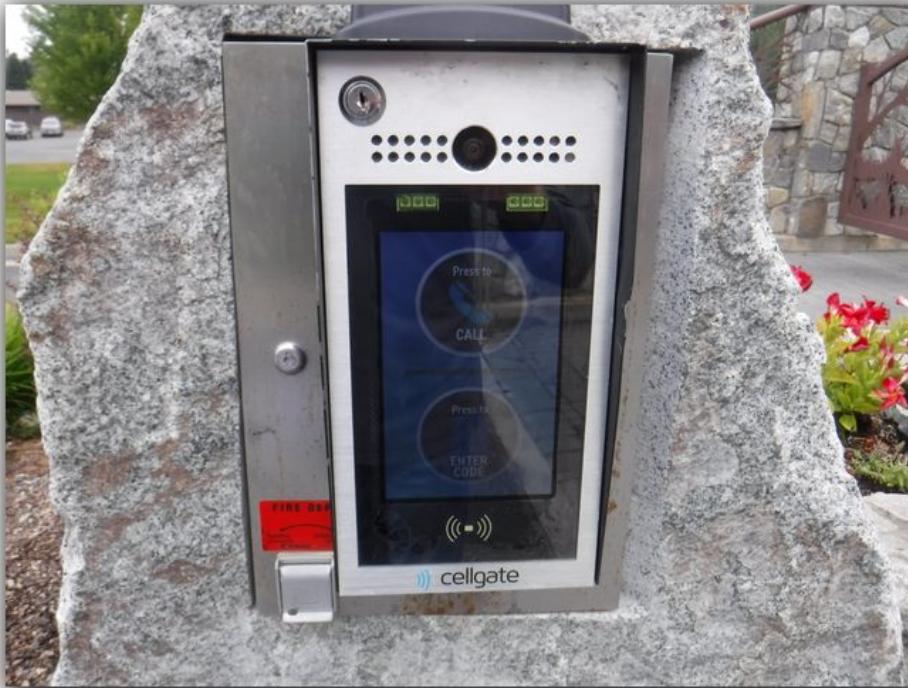
8

New entry gate keypad

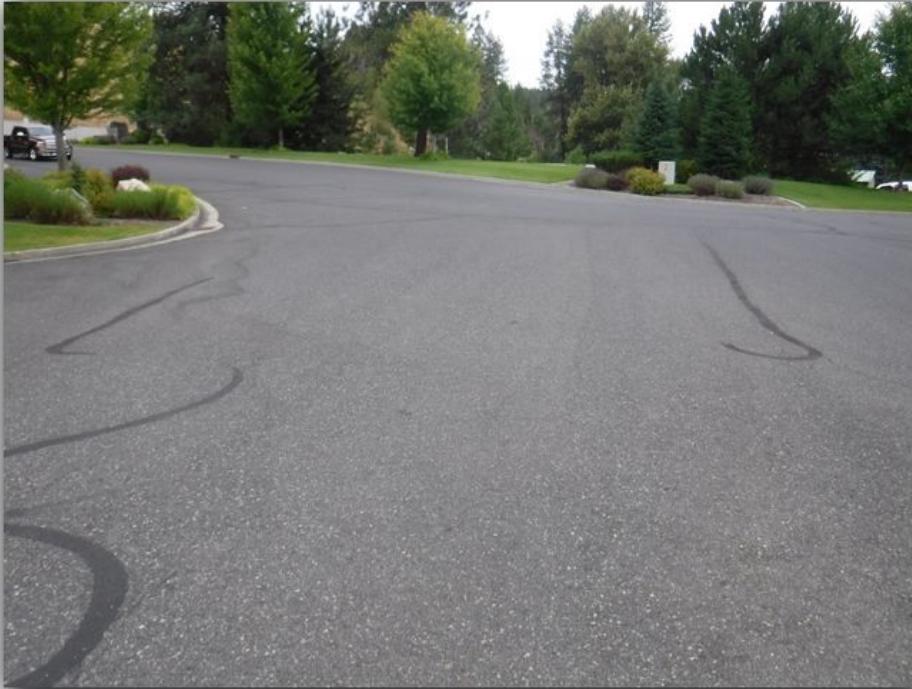
9

Wandermere Estates Lane

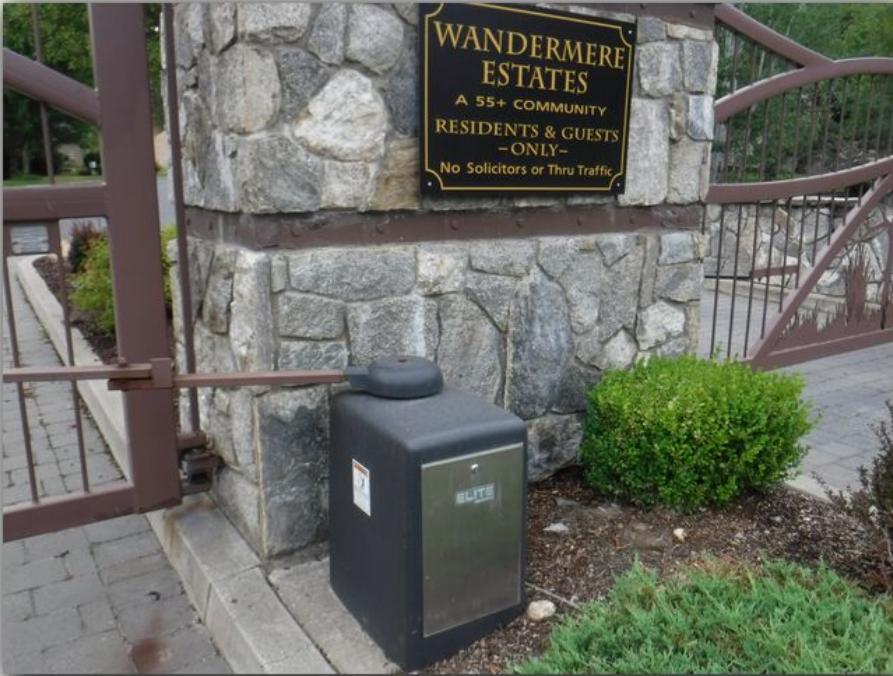
10

Gate and operator

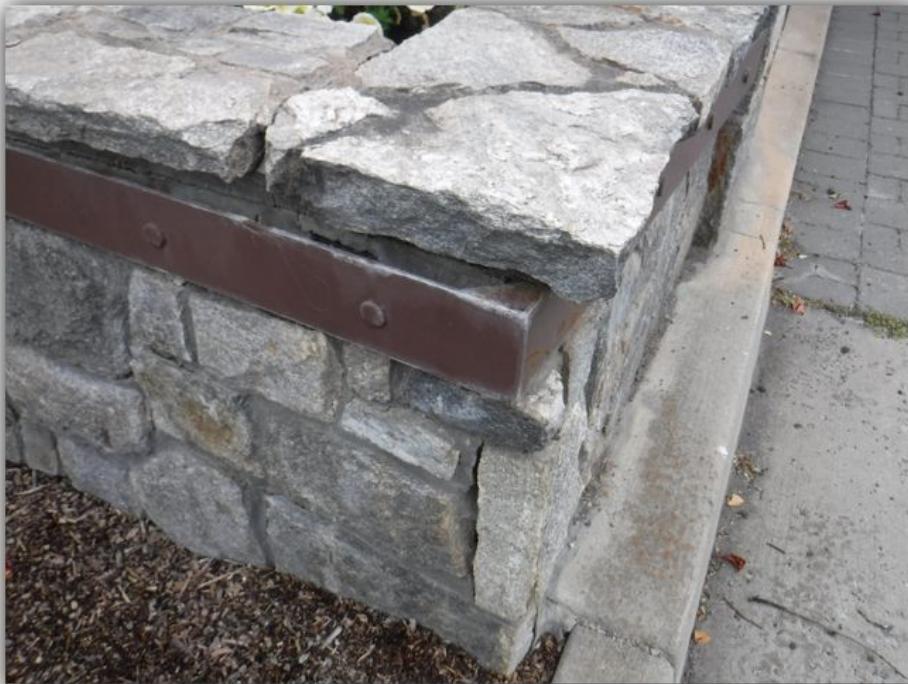
11

Loose steel band at entry bridge

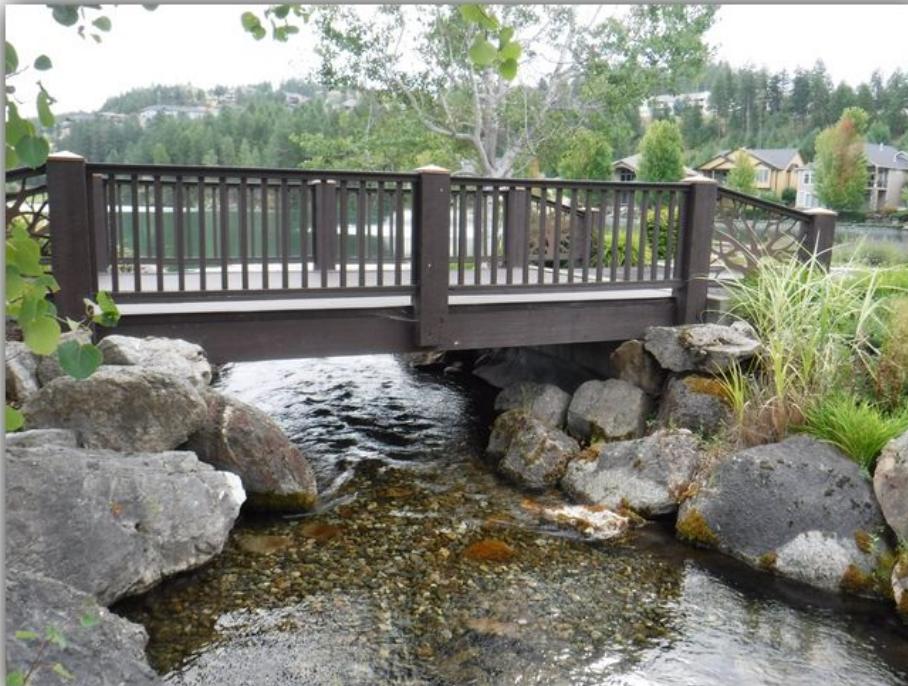
12

Pedestrian bridge

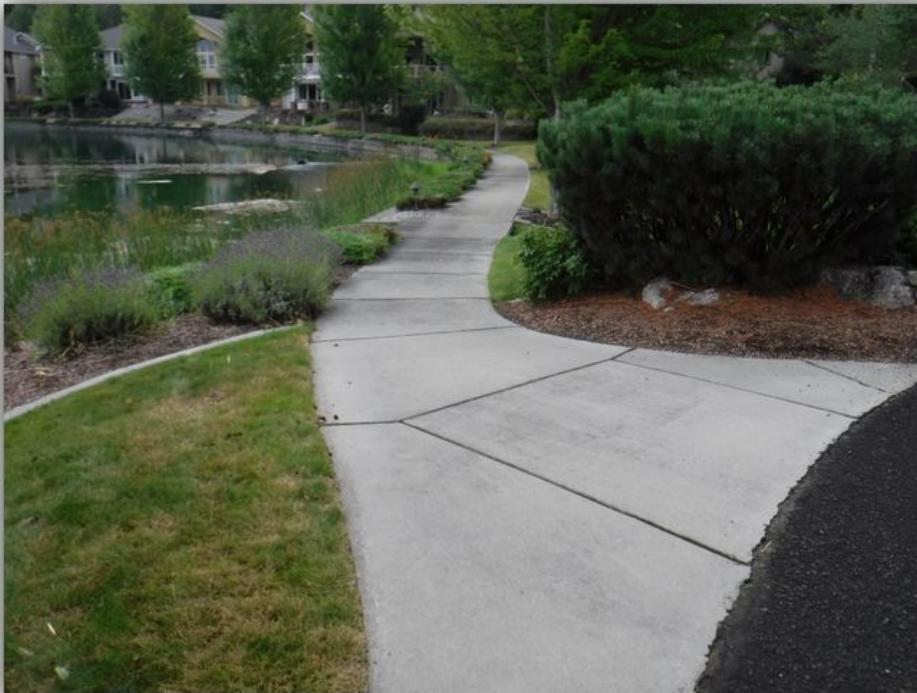
13

Sidewalk along lake

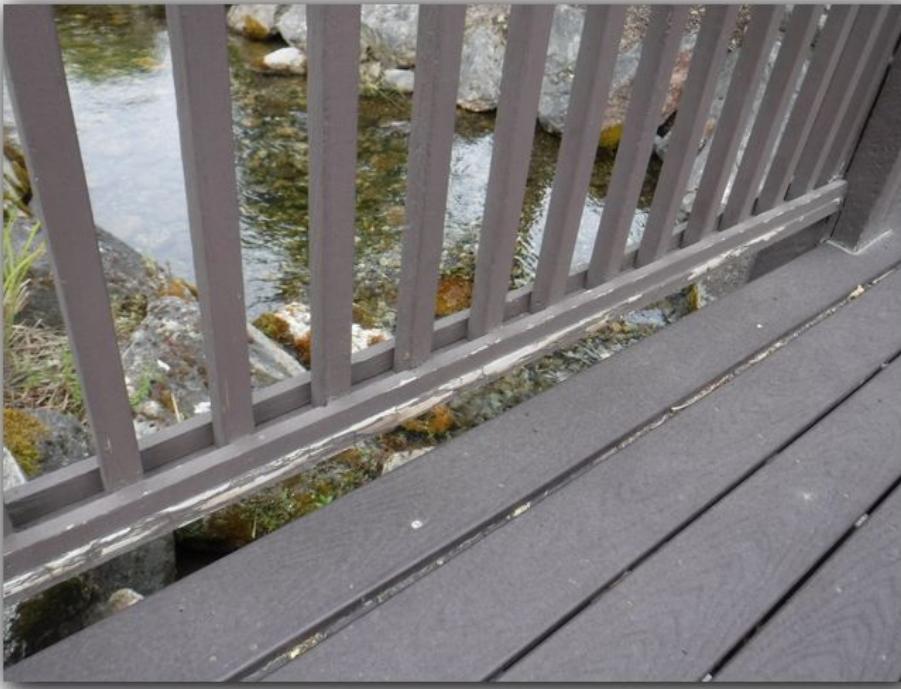
14

Pedestrian bridge railing
needs paint touch up

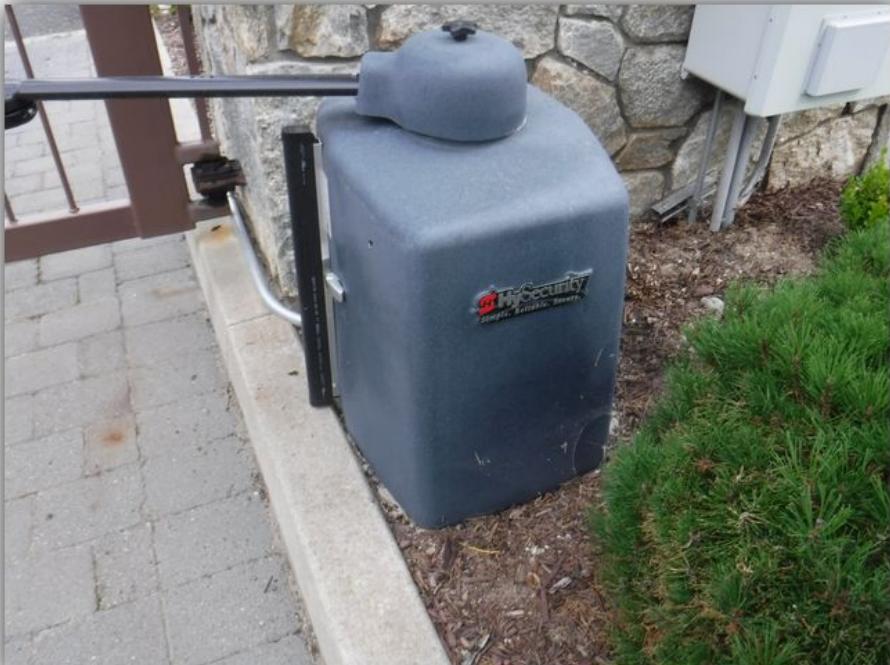
15

Entry gate operator

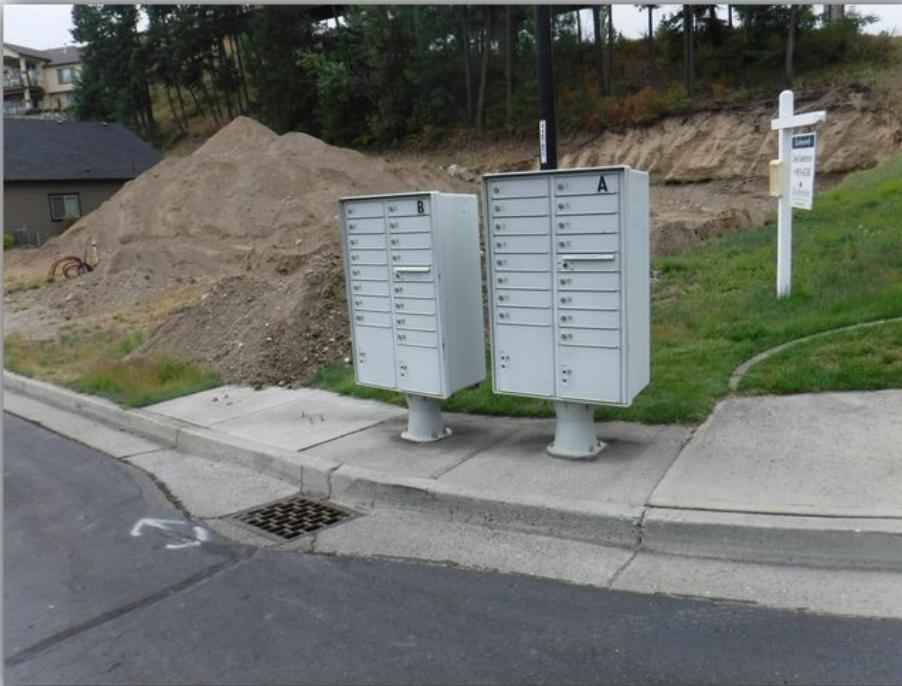
16

Typical cluster mailboxes

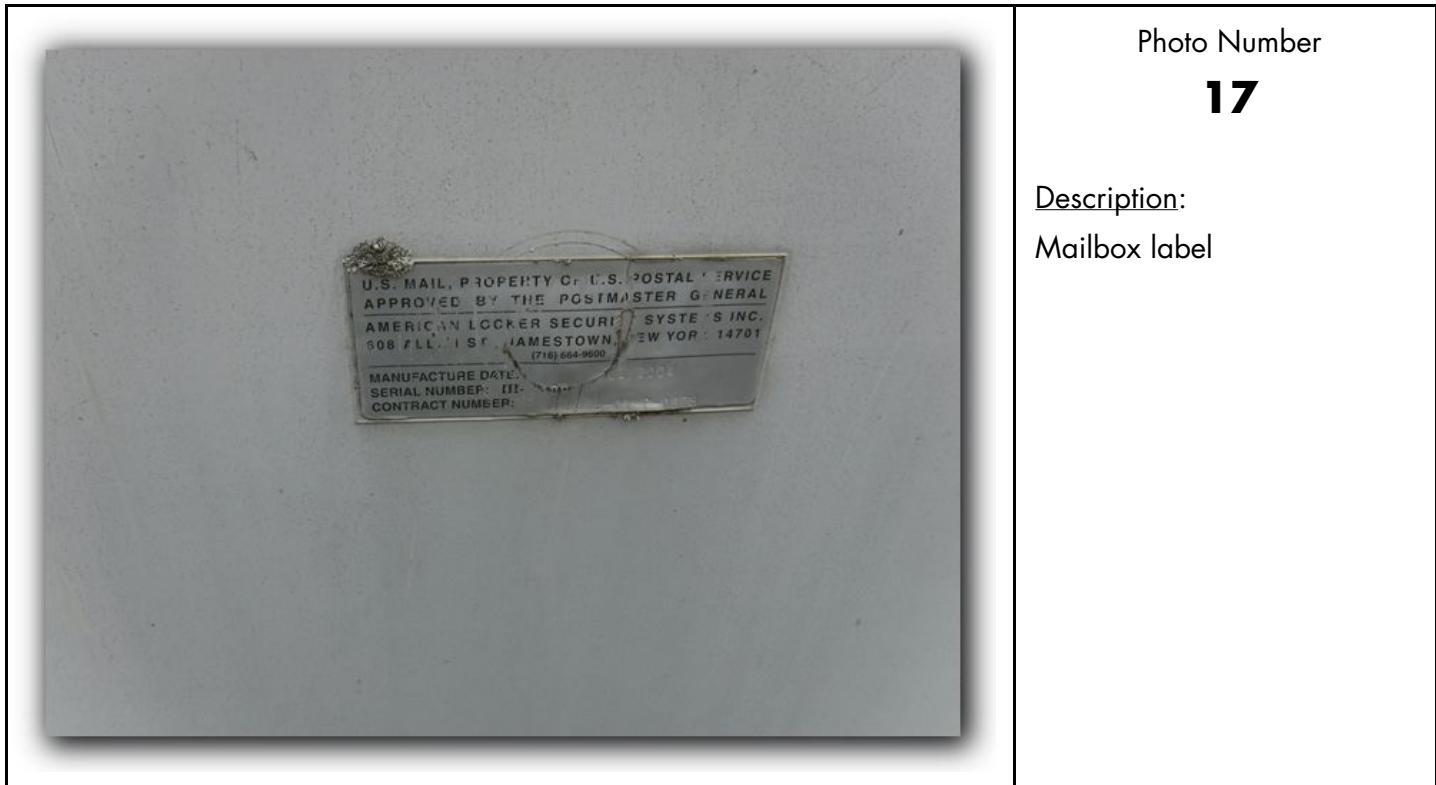
17

Mailbox label

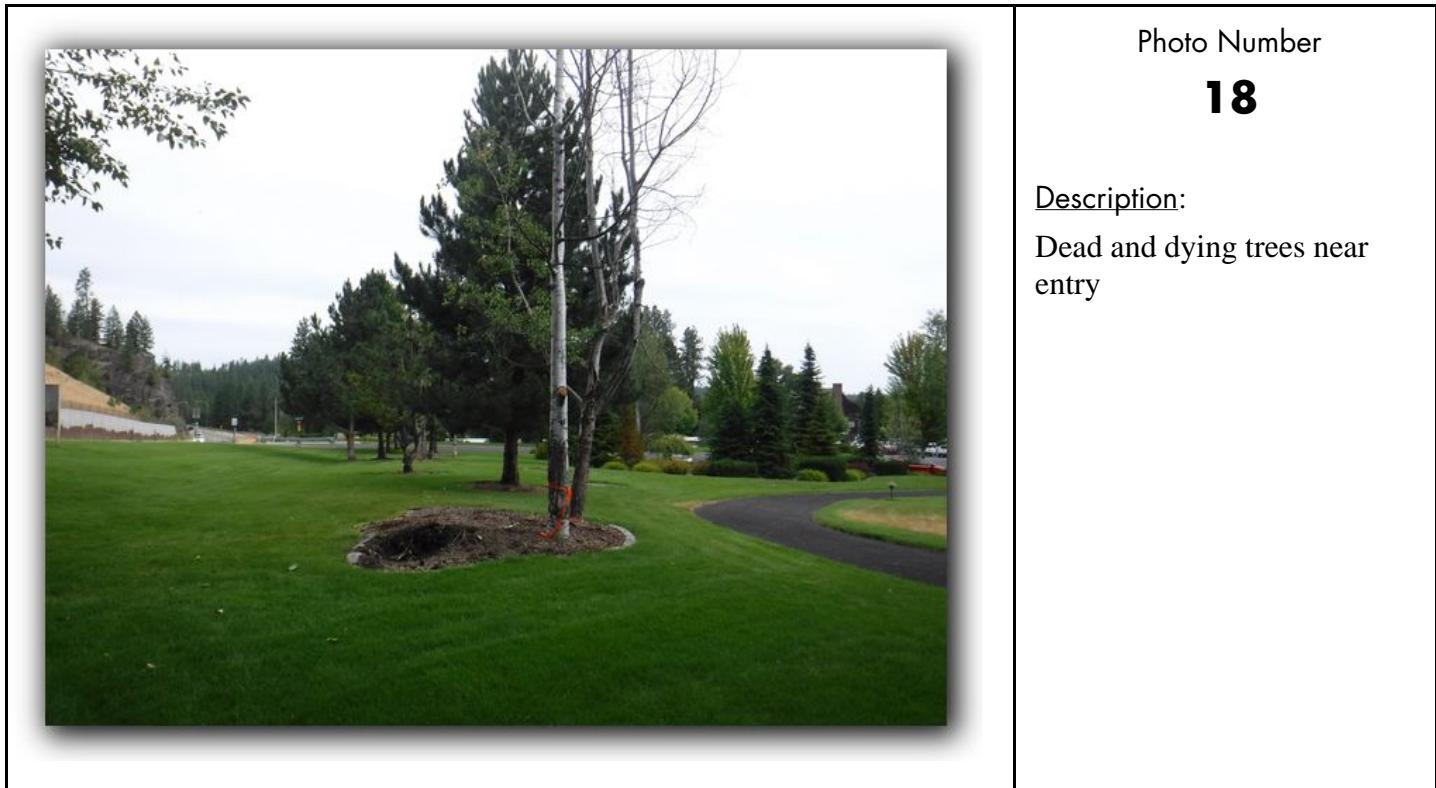
18

Dead and dying trees near entry

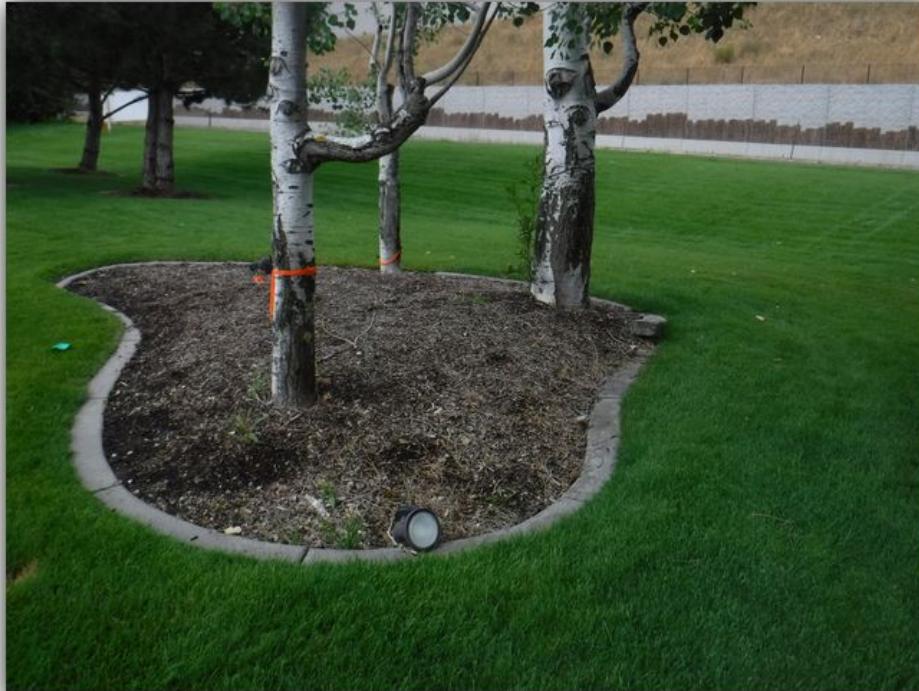
19

Uneven concrete border due to tree roots. Lights poorly aimed and supported.

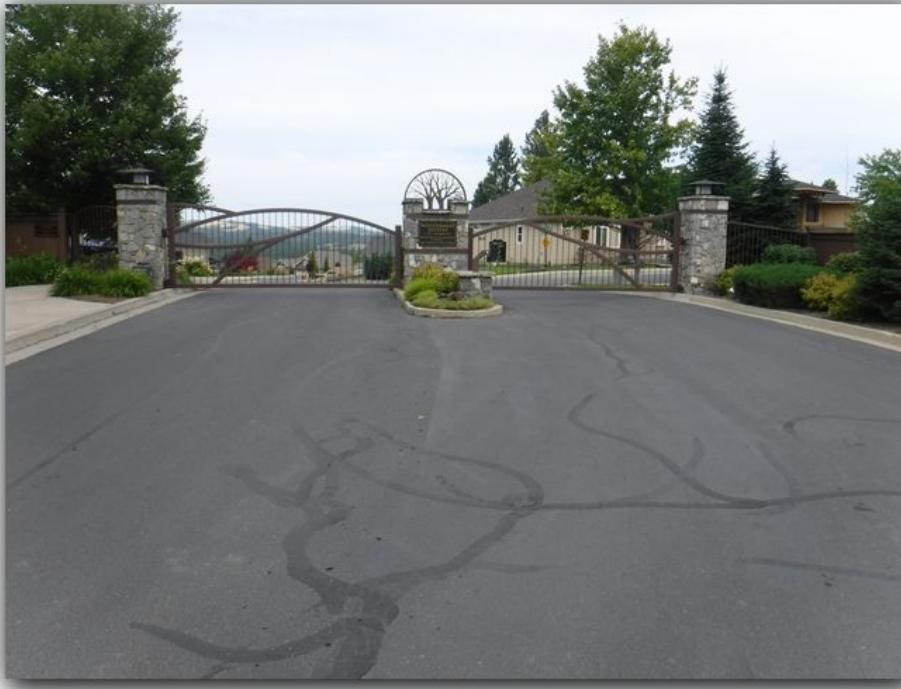
20

Upper entry

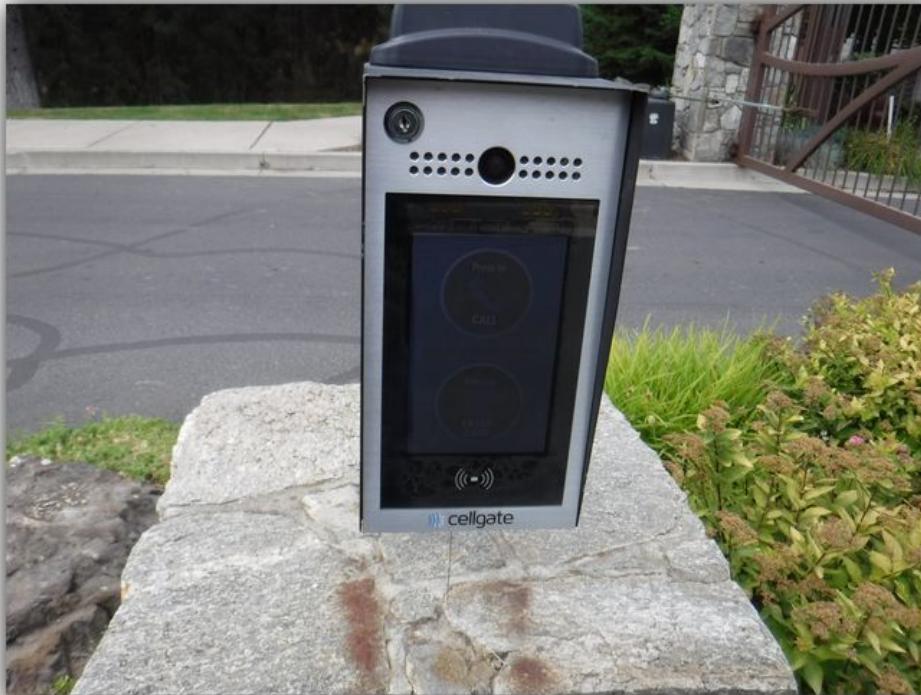
21

Upper entry keypad

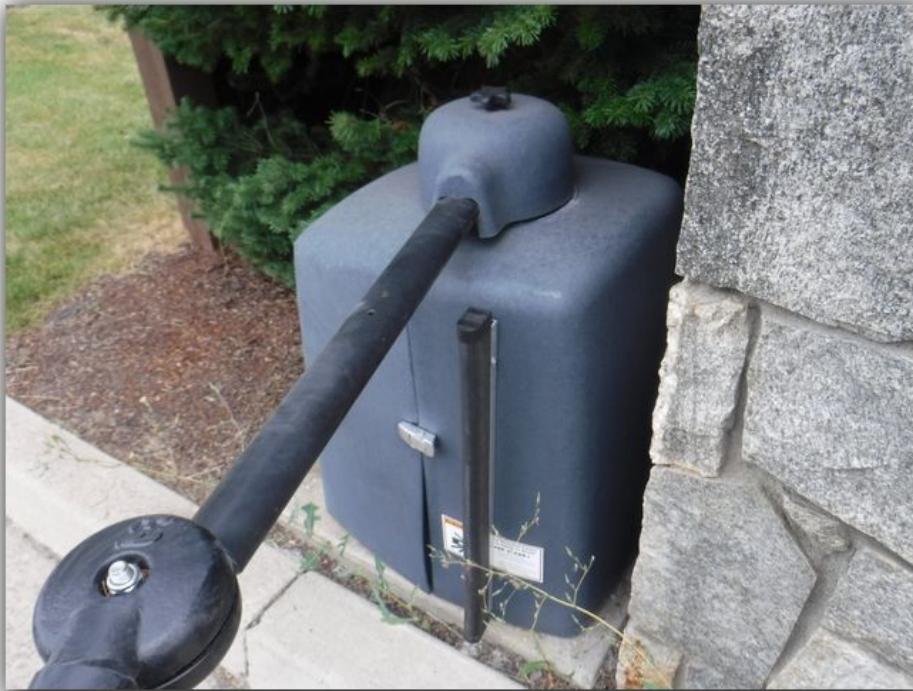
22

Upper entry gate operator

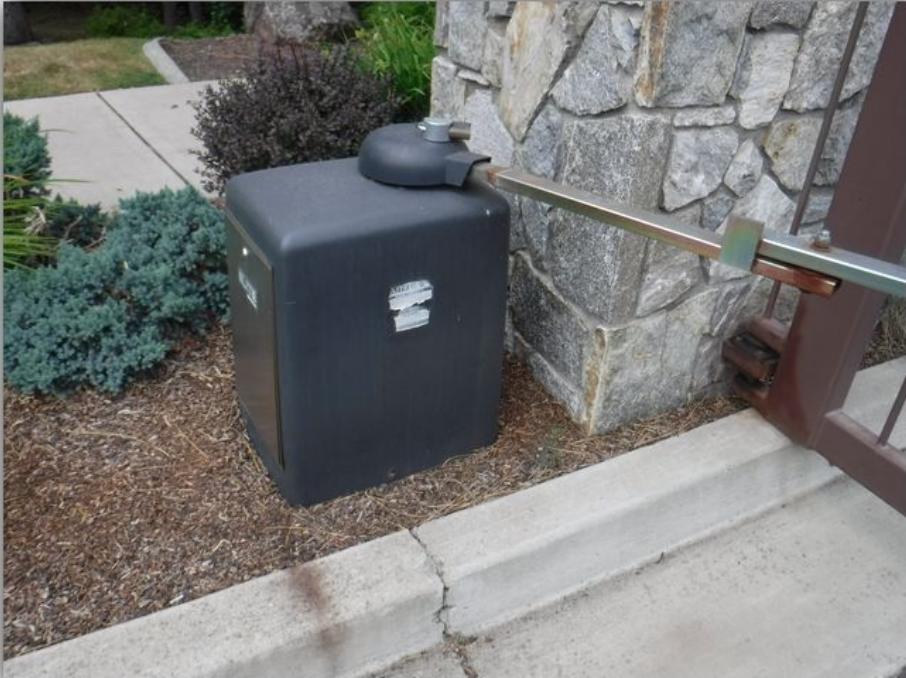
23

Upper exit gate operator

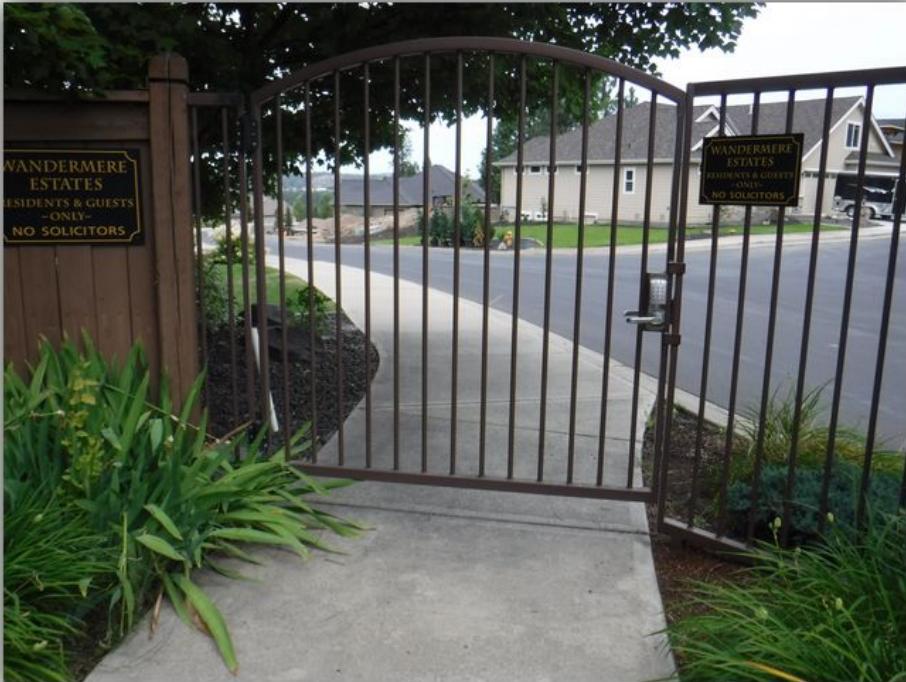
24

Upper pedestrian gate and sidewalk
