Project S17206

## Memorandum

**Project: North Wandermere Estates Lane, Spokane, WA**  
**Subject: Results of Limited Geotechnical Evaluation**

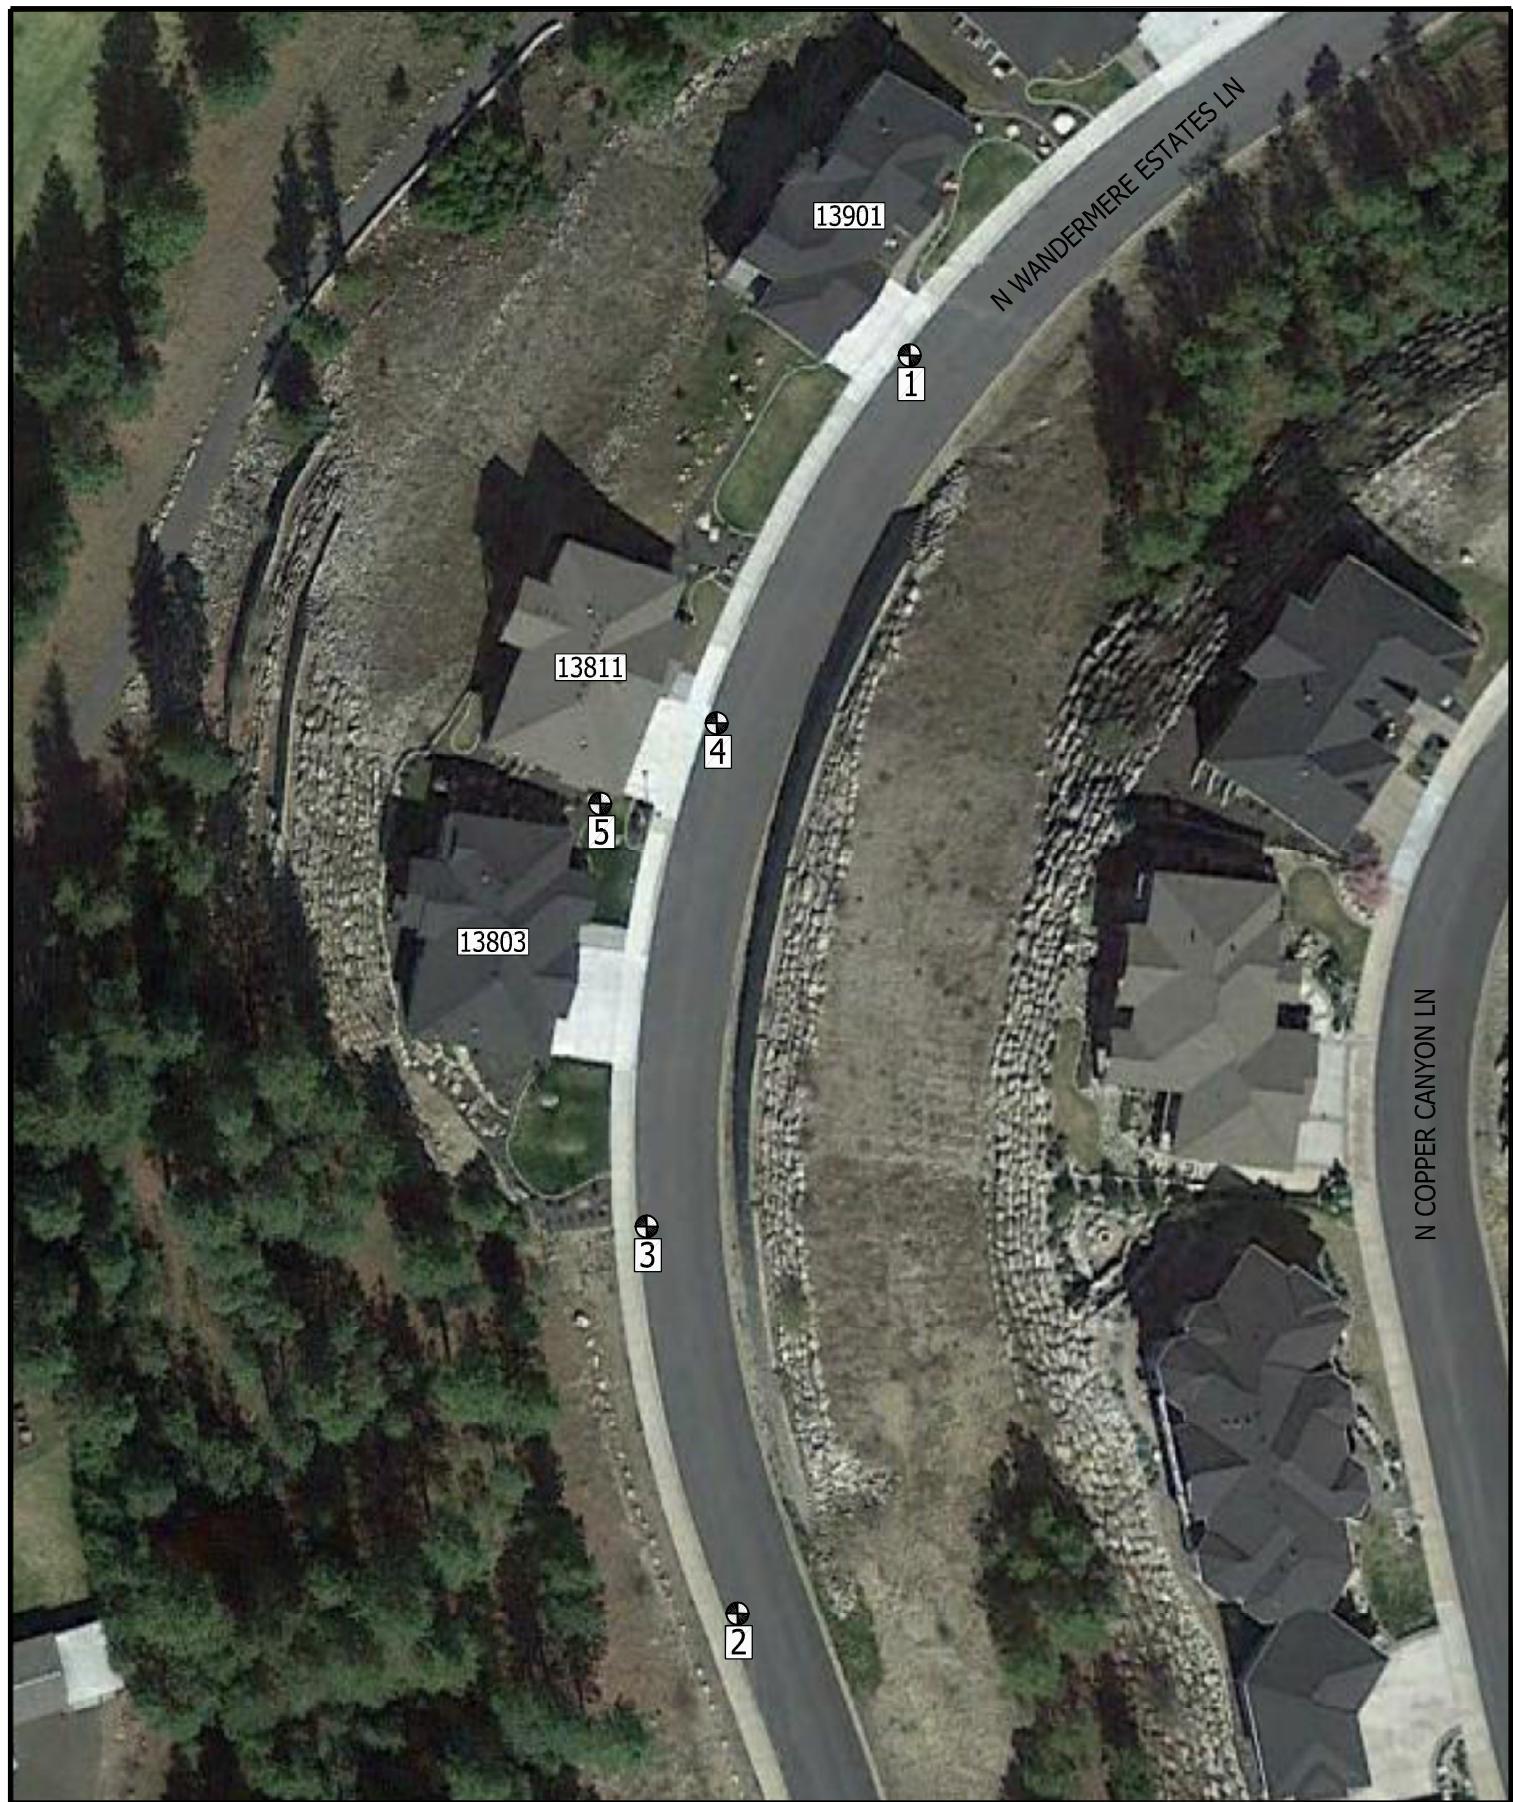
FIGURE 2

Between the front portions of the homes at 13803 and 13811, and up-slope of the existing scarp, we drilled a boring to a depth of 44 feet and installed casing for an inclinometer. The inclinometer casing extends 30 inches above ground surface. The lowest measurement depth from top of casing is 46 feet. The purpose of the inclinometer is to detect, locate, and measure horizontal displacement along a particular subsurface interval within a soil or rock mass. The measurements are taken continuously at 2-foot depth increments over the length of the casing. The rate of movement is observed by conducting the measurements over intervals of time.

We conclude that the soil under the existing road is currently stable. However, the head-scarp of the active landslide is currently approximately 55 feet from the edge of curb. Progression of this scarp further toward the road, or development of secondary scarps would increase the risk of damage to the roadway and related improvements. Although no groundwater was observed in explorations, the location of the site relative to the surrounding terrain suggests that stability of slopes could be affected if subjected to water infiltration.

1. Capture and direct spring water on the uphill side of the road adjacent to the slide into the storm drainage system. In order to mitigate the current land subsidence, we recommend eliminating the potential for water to infiltrate exposed ground west of the road.
2. Assuming the 13811 home is removed, regrade the slope at the lowest practicable angle to the sidewalk.
3. Assuming the 13803 home is to be saved, consult with the homeowner to determine the appropriate means of stabilization.
4. Continue monitoring the inclinometer for slippage at least once per month.
5. Consider adding a second inclinometer on the north side of 13811.
6. For long-term monitoring, retain a surveyor to install and monitor approximately 5 ground surface points for vertical and horizontal displacement along the curb and sidewalk.

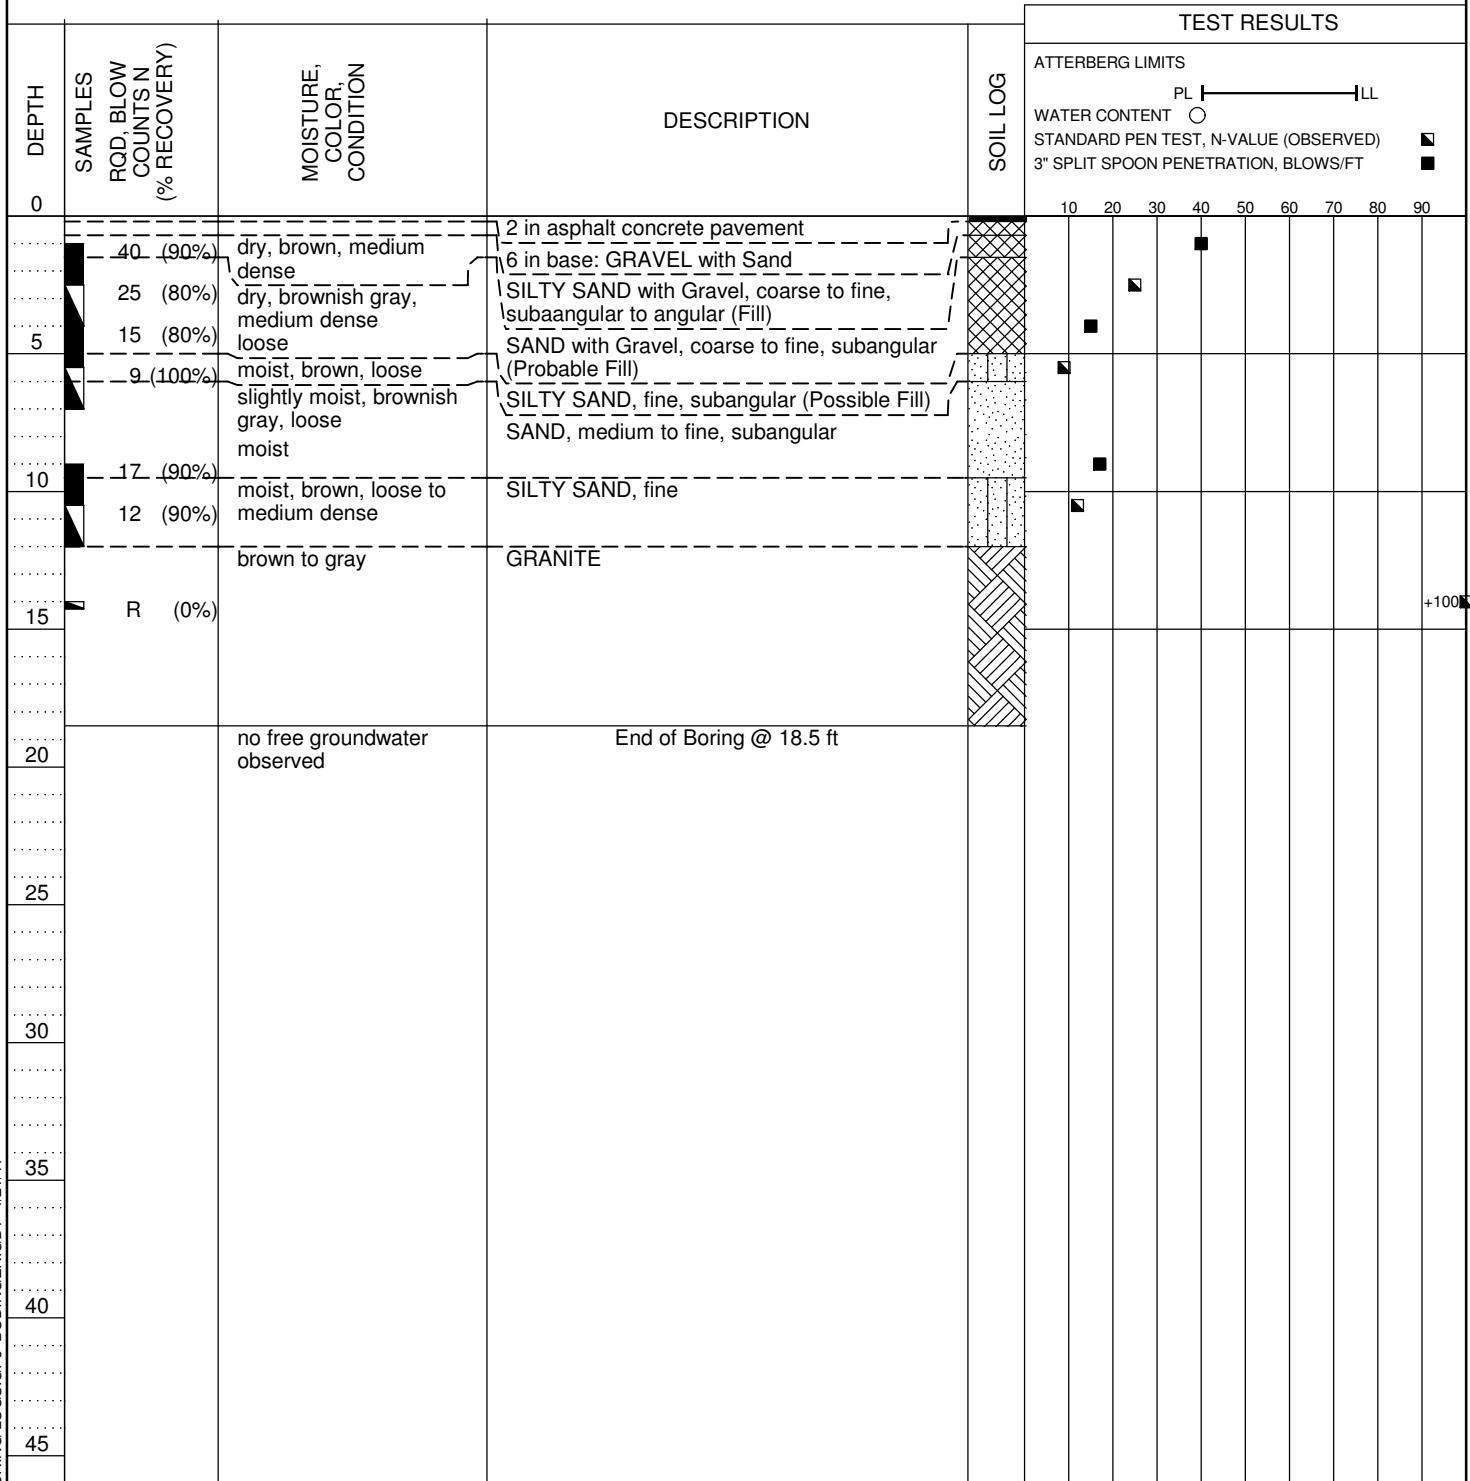
### TEST BORING 3

A relatively thin layer of *Silty Sand* was encountered in Boring B-3. This 2 1/2 -foot thick layer was present at 9 1/2 feet in depth. The *Silty Sand* ranged from loose to medium dense.
