Daily Field Report

S17206A1-1

PROJECT I.D. Wandermere HOA

N. Wandermere Estates Lane

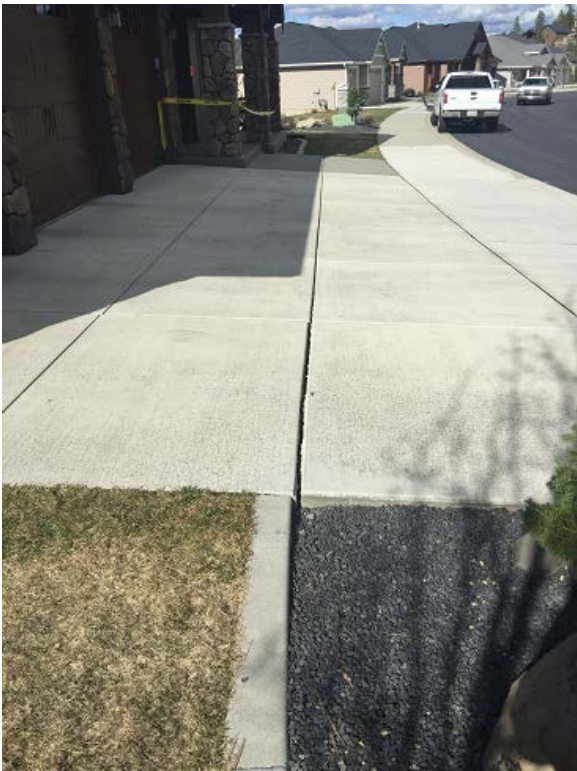
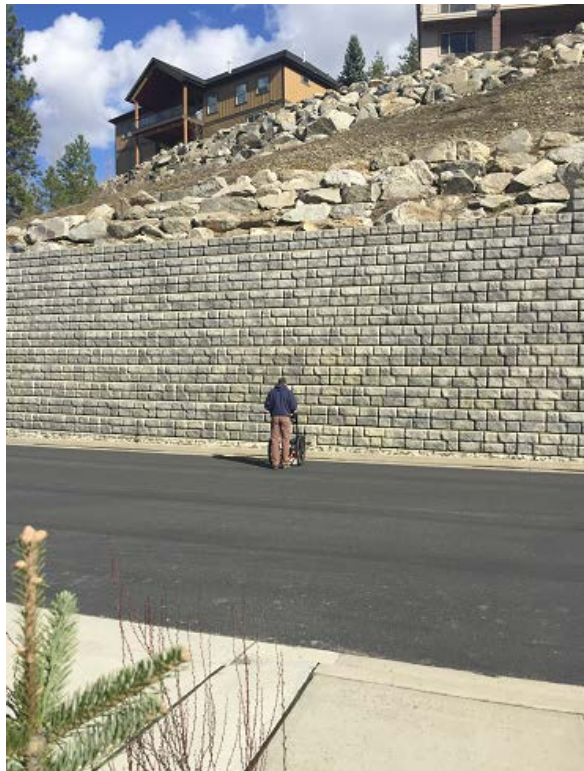
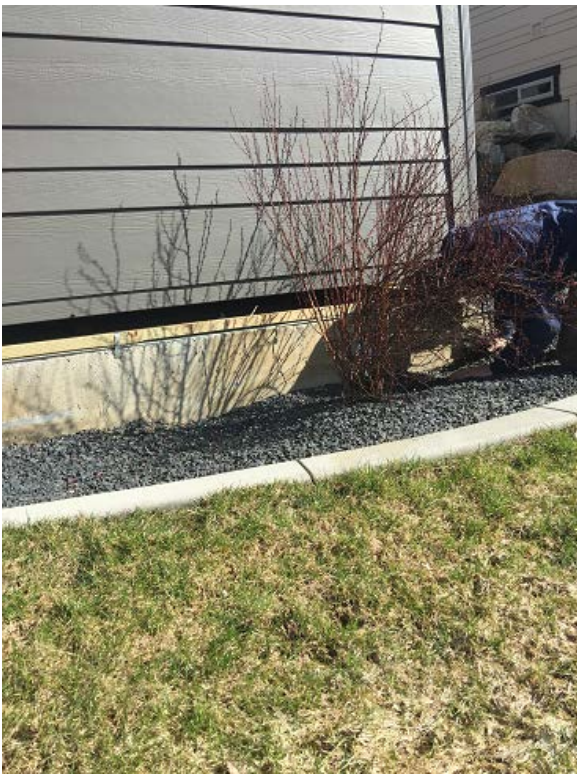
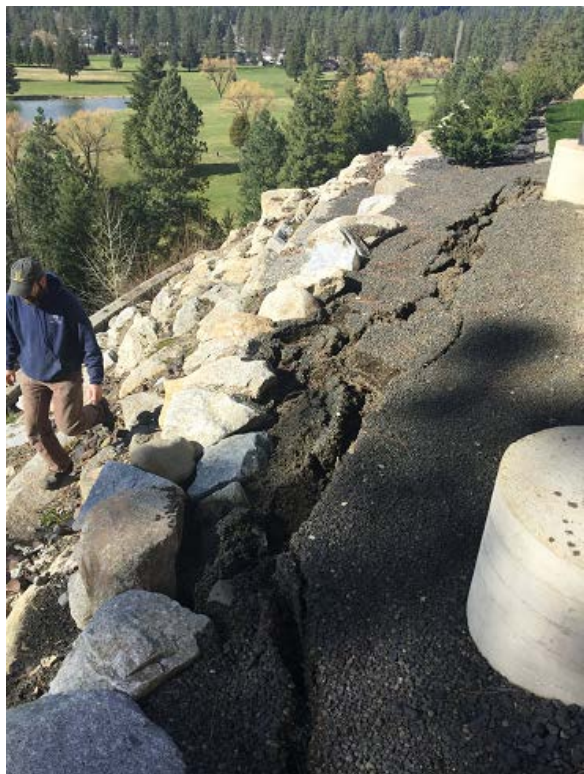
We conducted multiple ground penetrating radar (GPR) surveys along Wandermere Estates lane right-of-way from approximately home address 13803 to 13909. Our scope of work was to attempt to locate potential voids beneath the road that may be present due to an uphill spring and downhill developing landslide. We observed an existing retaining wall on the east side of the street across from home addresses 13803 and 13811. A spring was also present on the east side of the street approximately 50 feet south of the aforementioned retaining wall. GPR surveys did not appear to indicate voids beneath the road.
